BLACK WARRIOR/TOMBIGBEE RIVER: DEMOPOLIS LOCK – UPPER MITER SILL FAILURE – 16 APRIL 2024

16 April 2024 condition update:

BLACK WARRIOR/TOMBIGBEE RIVER: DEMOPOLIS LOCK – UPPER MITER SILL FAILURE - 16 JAN 2024

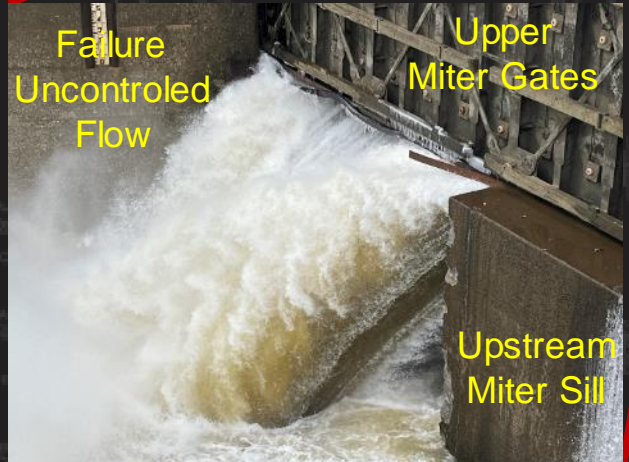
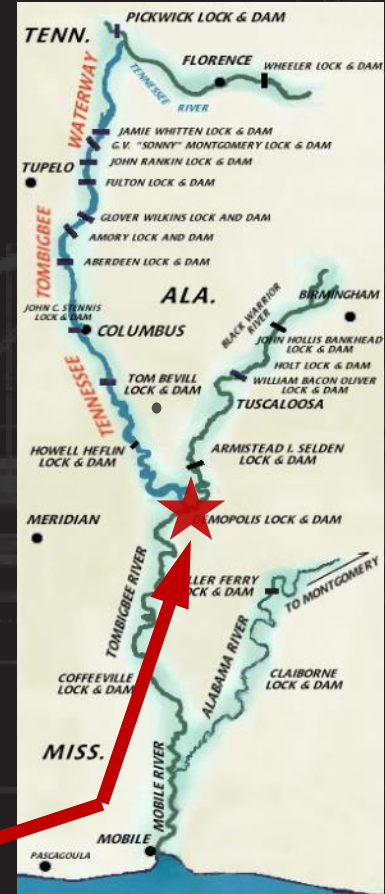
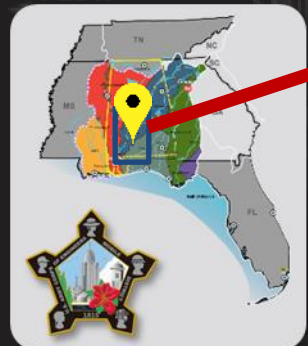
16 January 2024 Incident:
At 0600 the on-duty lock operator heard a loud noise and while investigating noticed water flowing under the upper miter gate. The concrete that comprises the upper miter sill fractured, allowing water to pass under the gate. The lower lock gates were open at time of the incident.

At this time, the extent of damages have not been determined. Once the lock is dewatered damage assessment and repair plans can be developed. No accurate estimate for closure duration is available at this time. This schedule will be refined once a full assessment of the damages can be performed.

Current operations are to close the lower miter gates to allow the pool to equalize and set the upper stoplogs to get the lock chamber under control. Operation will take place 19-21 January. Engineering and Operations are continuing to analyze the extent of damages and are working other courses of action to stop the flow and get the lock under control.
