# Claiborne and Millers Ferry Locks and Dams Fish Passage Study

SUBJECT: Potential Failure Mode Analysis and Screening-Level Risk Assessment – Claiborne and Millers Ferry

# Screening-Level Risk Assessment Claiborne and Millers Ferry Fish Ladders

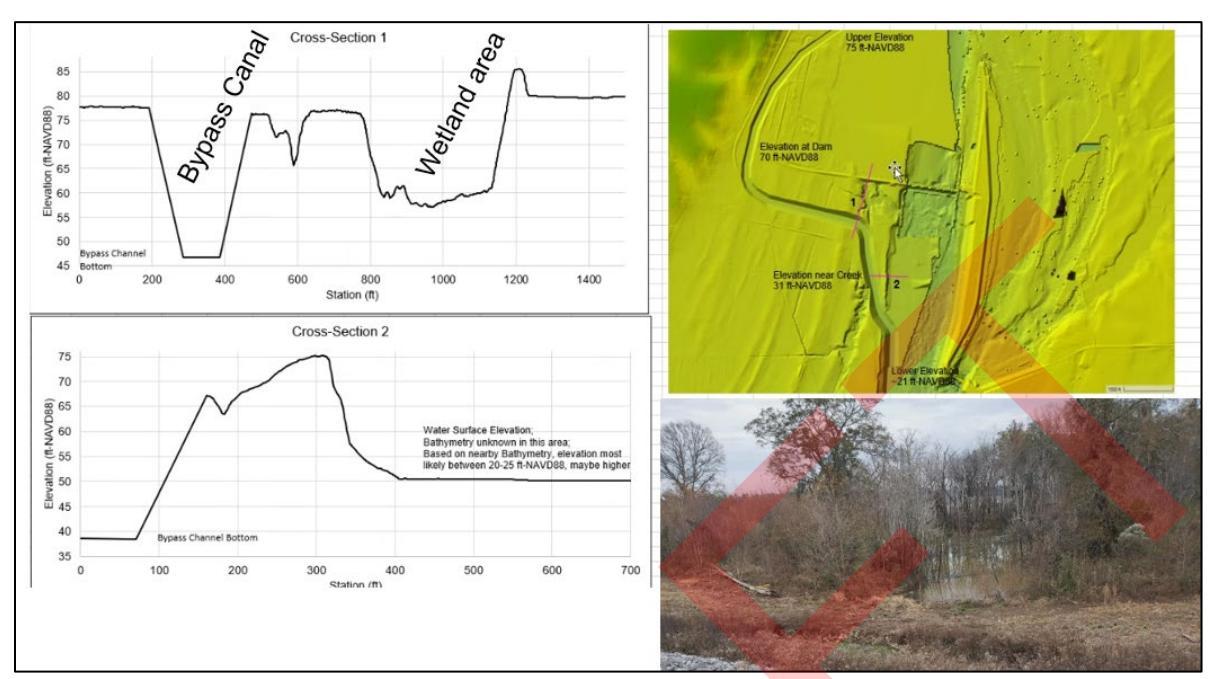
The following Figure 8 shows a topographic map of the dam. This image shows the location of 2 cross sections cut through the dam and through the fish passage channel. Cross section 1 also cuts through an existing wetland on the downstream toe of the dam. This wetland is a natural low area that is as deep as 15 feet below the surrounding ground surface. This area remains wet all year and overflows back into the river after significant local rainfall events. This figure also shows a photograph of the wetland area.

Figure 8 – Cross section through conceptual fish bypass canal and existing wetland area.

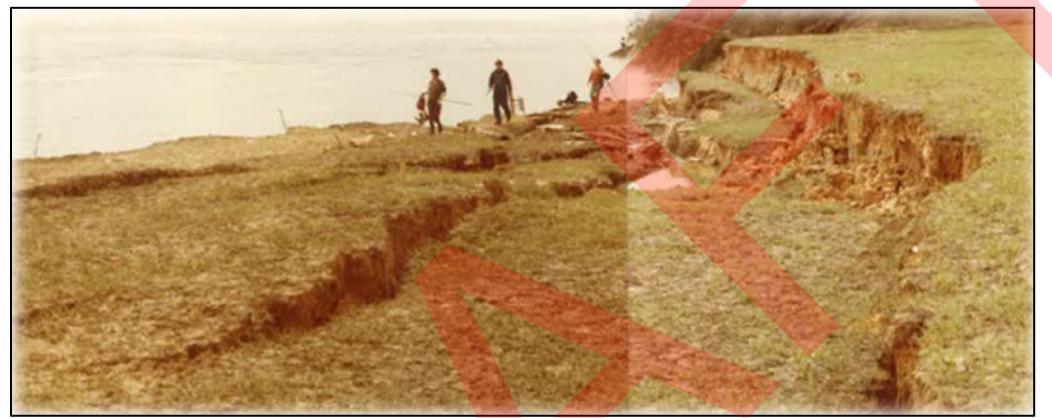
Claiborne L&D has not had any incidents or failures at the project since construction; however, historically there has been erosion on the right streambank downstream of the overflow dike. Figure 17 and Figure 18 are pictures taken in April 1977 and included in Periodic Inspection (PI) No. 6 in 1978 that show the bank failure caused by the erosion. In 1977, a project was designed to remediate the erosion. A combination of riprap, grouted riprap, and bedding material was used to fill in the erosion areas shown in Figure 19. Typically, plastic filter cloth was used beneath the bedding material for areas that did not contain grouted riprap.

During the last PI, the elevated tailwater made it impossible to fully inspect the grouted riprap voids. Previous inspections identified voids/differential movement beneath the grouted portion of the riprap created by some erosion of the underlying fill; however, the water was too high to view during that inspection to evaluate their condition. There had been concerns about embankment material being piped from beneath the concrete overlaying the crest. In 2014, the Mobile District cored several holes into the concrete cap to determine if the feature had been undermined but no voids were detected. Figure 20 shows more current 2023 picture of the differential movement between grounded and ungrouted riprap.

Figure 18 – Right bank erosion area, facing downstream 1977.

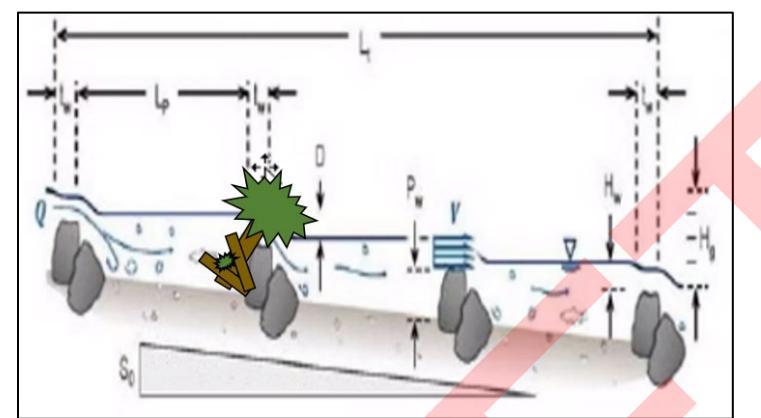
Boulders used to build the fish ladder pools will restrict flow velocities. Figure 39 illustrates the use of boulders and rubble to make a series of pools that restricts velocity in the channel to less than 5 to 6 fps and less than 2% slope making a debris jam likely over the service life of this project. The rock steps will tend to trap floating debris and even small debris could get caught between boulders and begin to form a debris dam. Debris has been observed in the Alabama River during past storms evidenced by the

Figure 39 – Boulders create pools that restrict velocities.

It is recommended that debris booms be included in the design to limit to quantity of debris floating through the control structure gates. Once alignment is finalized, the channel should be modeled with debris jam and verify where out of bank flow would go and what areas would be inundated from such an event, assuming the debris dam is near the upstream end of the fish ladder. It should also be required to inspect the channel after a high-water event to verify and/or remove debris from the channel. Revision of the EAP and Surveillance and Monitoring Plan should include inspections of the channel in addition to inspections of the dam. Installation of cameras would allow for remote monitoring of possible blockage or sediment buildup in the bypass channel during regular use.

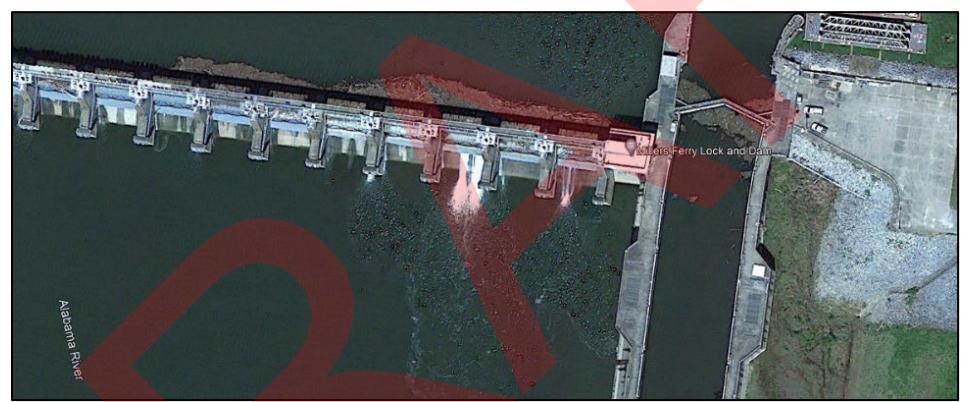
Google Earth Imagery in Figure 40 that shows debris stacked against the spillway and Tainter gates from March 2019. For these reasons, a debris jam is considered likely over the service life of the project.

Figure 40 – March 2019 Google Earth Imagery showing debris stacked against the spillway and lock gates.

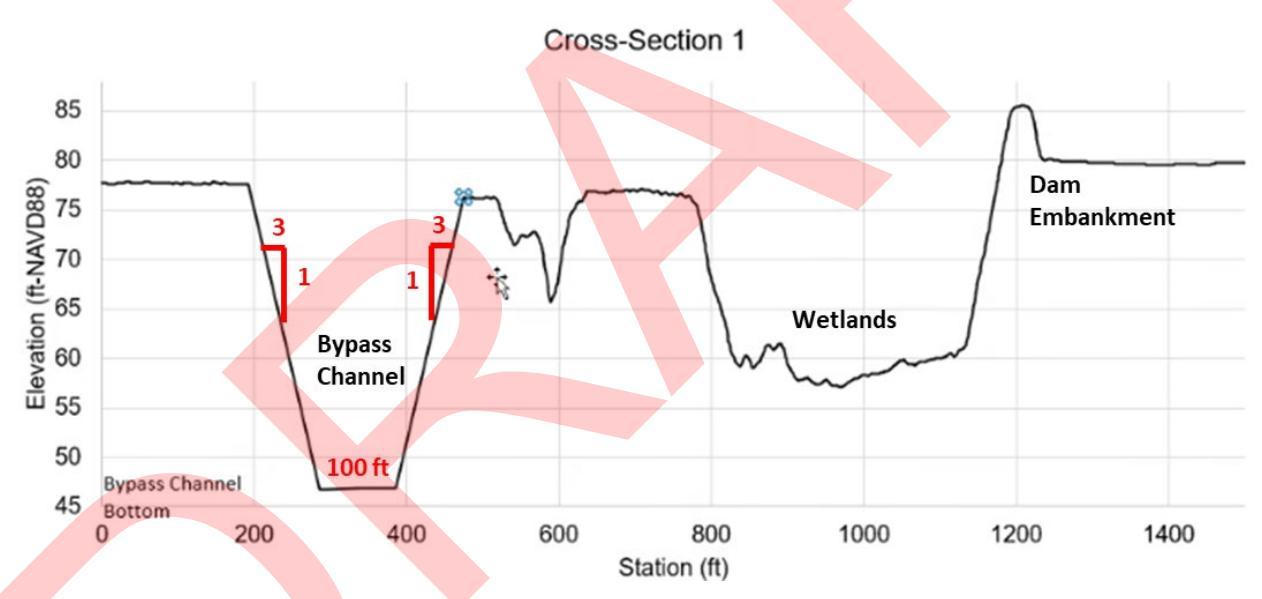
The fish ladder channel bottom width of 100 ft with a 3:1 (horizontal:vertical) slope, as shown in the cross-section in Figure 41 These dimensions would require a lot of material to completely block the flow through the channel. The geometry of the channel should allow flows to pass the blockage without overtopping the banks.

Figure 41 – Cross-section of fish ladder channel dimensions.

While there is a high probability of blockage occurring at some point during the service life of the project, the chance of blockage resulting in dam failure is judged to be remote based on the width of the channel and the very long duration out of bank flow would have to continue to progress to breach. Therefore, this PFM is excluded as a risk driver, but it is an operation and maintenance consideration.

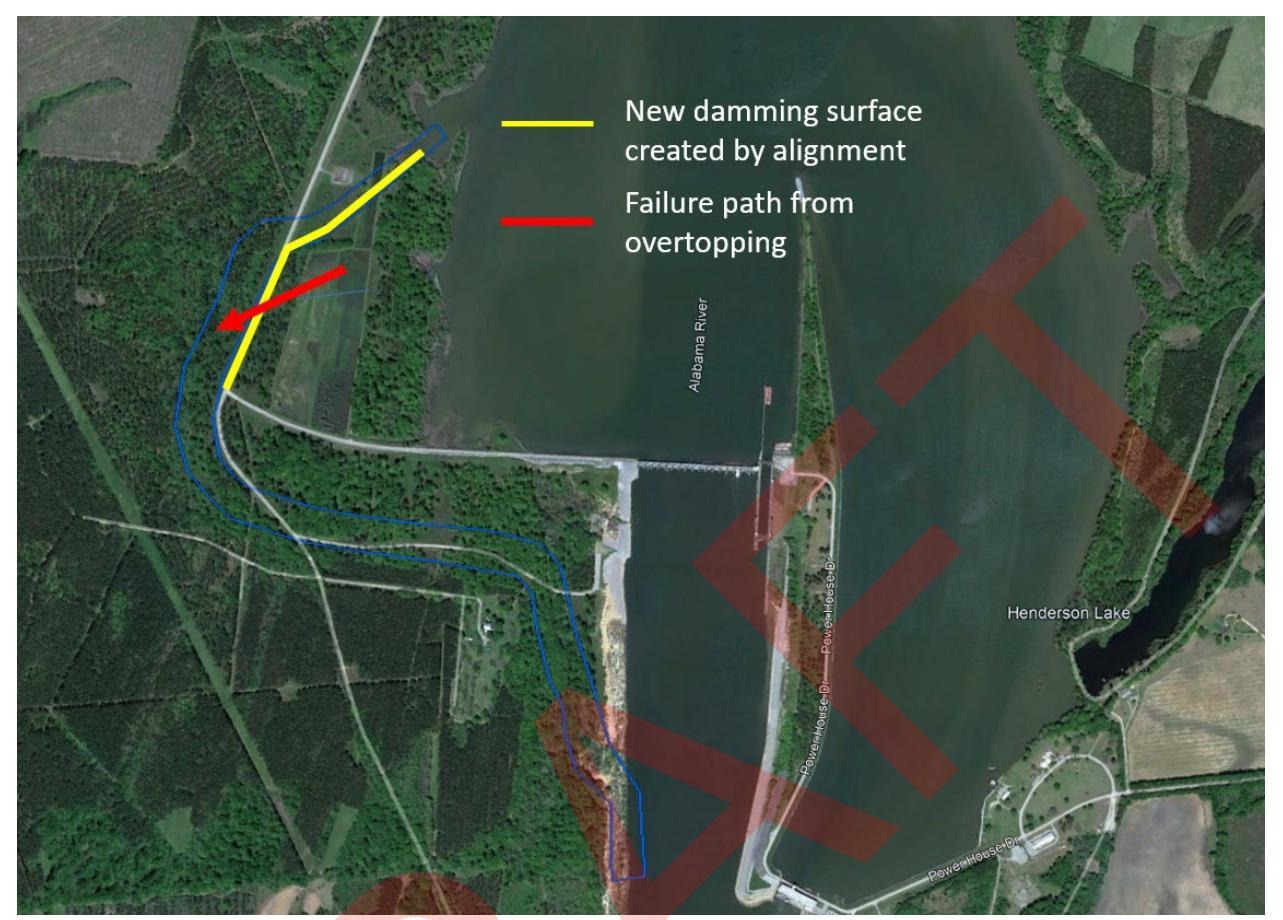
Description: An alignment is selected during optimization that routes the channel around the right abutment of the dam. The main dam and right abutment overtops during a flow event less frequent than an approximate 1/15 AEP flood event. As the flood recedes, overtopping velocities over the new damming surface and into the fish ladder channel begin to erode and head cut back through the earthen embankment allowing uncontrolled release of water around the right abutment, resulting in loss of service and benefits of the fish ladder channel. This failure path is shown in Figure 42.

If an alternative alignment is selected that allows flow around the right abutment, the dry island created between the normal stage river path and the fish ladder will become a new damming surface, shown in Figure 42. This PFM was not evaluated in detail since this is not the TSP alignment and since critical details like gate location are not yet known. If the gate is in line with the existing dam then the "island" would not become a damming surface, likewise, if the gate were at the channel connection to the river, the damming surface shown in Figure 42 would exist. If this alignment were selected, it would need to be evaluated for a variety of PFMs including overtopping, slope instability and all PFMs related to seepage.

Figure 42 – Location of where new damming surface is needed with alignment.

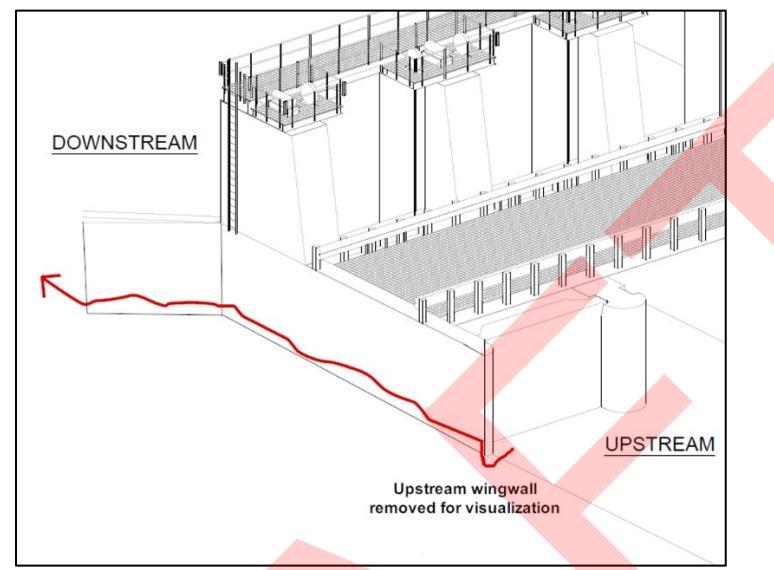
The preliminary drawings show vertical sides to the structure which can preclude intimate contact between the clay backfill and the concrete and the footing is sown as a 90-degree connection. This could potentially result in a zone of low stress along the structure and a preferential seepage path shown in Figure 43. Figure 44 shows the location where the flaw could potentially occur from poor compaction adjacent to the structure. The current conceptual drawings also do not show any type of filter for this structure. This leads to conditions where Concentrated Leak Erosion (CLE) would be more likely.

Figure 43 – Failure path along the gated structure.

Several recommendations were provided in the Findings and Recommendations Section of this report that are considered standard practice and are expected to be captured in the design during PED. This PFM was excluded as a likely risk driver with the expectation that these standard features would be added. It is recommended to modify the design to 10V:1H battered side walls and any 90-degree corners be chamfered to fill in those corners where compaction will be difficult. The team also

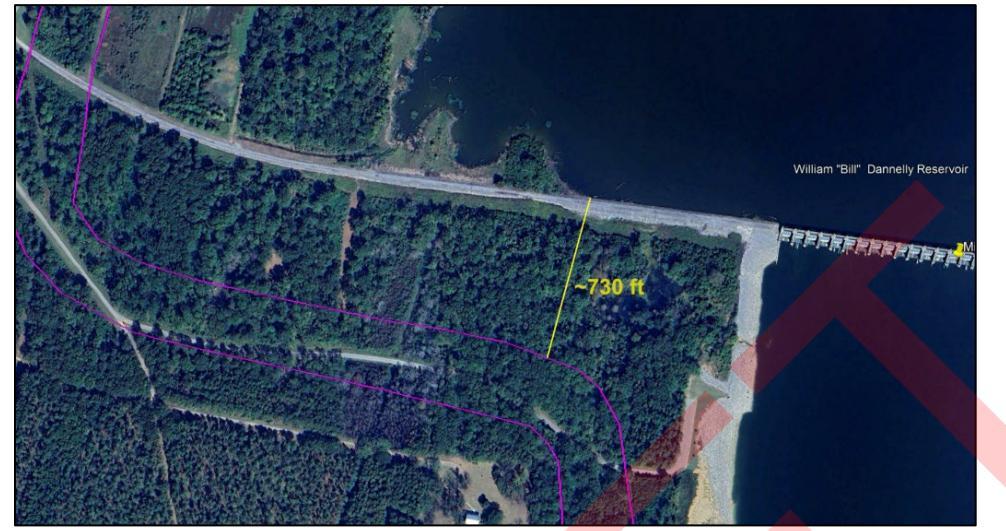
There are two sources of head differential and therefore two potential BEP failure paths associated with BEP: one from the upstream pool to the fish bypass and the other from the fish bypass to the downstream pool. The path from dam to bypass channel is the only one that would progress to breach of the dam and is therefore the focus of this PFM. The invert elevation of the fish ladder channel drops at a 2% slope from the dam to the connection to tailwater. The critical location would be just before the turn in the channel where the exit gradients would reach a maximum. This path is measured at length of approximately 730 ft shown in Figure 47. At this location the bypass invert is at around EI. 46 ft. The fish ladder channel is designed for a depth of 4-5 ft, resulting in a bypass channel stage of approximately EI. 50 ft. The normal pool of the reservoir is 81 ft resulting in a head differential of 31 ft between the upstream and downstream fish ladder channel and average gradient of 0.04. Natural groundwater is between EI. 45-50 ft and dewatering would be needed during construction.

Figure 47 – Failure path for BEP between dam embankment and fish ladder channel.

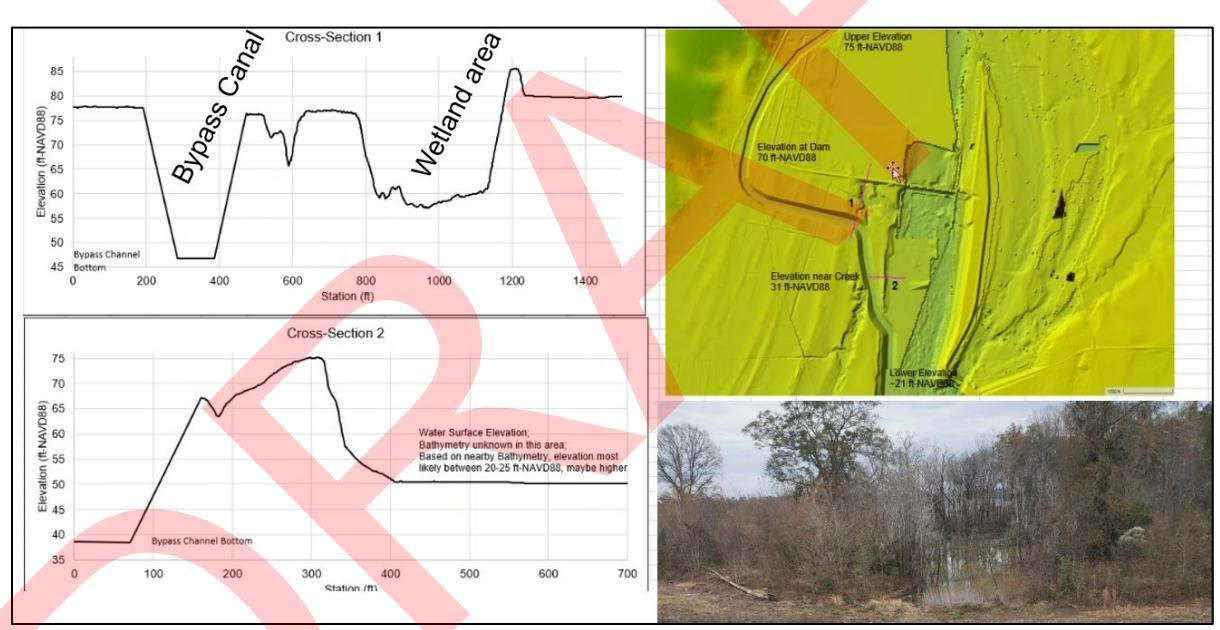
Lastly, Figure 48 shows a cross section through the downstream of the dam in the critical location for this PFM. The shallow wetland also exists on the downstream side of the dam in this area. Gradients into the wetland could be higher because it is closer to the dam. Assuming the wetland is near dry with water near the invert at El. 60 ft, the head differential is about 21 ft. However, the wetland is closer starting right at the embankment toe, this results in average gradients around 0.2 assuming a 100 ft seepage path. If a sand layer exists that is exposed by the wetland, these gradients are sufficiently high enough that they should have initiated BEP in the past. Given there is no evidence of BEP form past loading, this further supports exclusion of this PFM.

Figure 48 – Cross section through wetland.

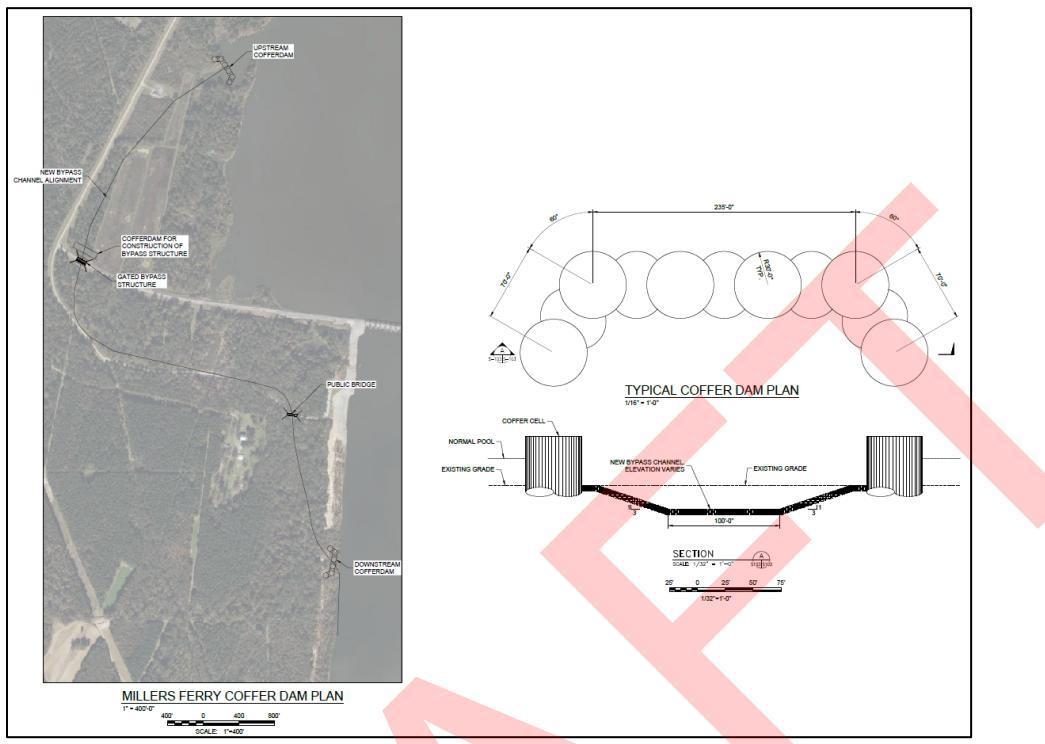
The current design indicates cofferdams are planned at the upstream and downstream entrances to the channel alignment, as well as just upstream of the gated fish ladder structure. Sheet pile cofferdams can leave a transverse defect within the dam during removal. If a sheet pile cofferdam is used upstream to downstream, pulling the sheet piles can leave a preferential seepage path in the clay fill that may progress to CLE over time. It is recommended that use of sheet piles be avoided in a transverse direction to the damming surface, but if it is required, abandonment by cutting off and abandoning in place may be preferential. This feasibility design includes cellular cofferdams that do not cross transvers to the embankment; therefore, this PFM was excluded at this phase of design. Figure 49 shows the conceptual cofferdam design.

Figure 49 – Typical Cofferdam design plan.

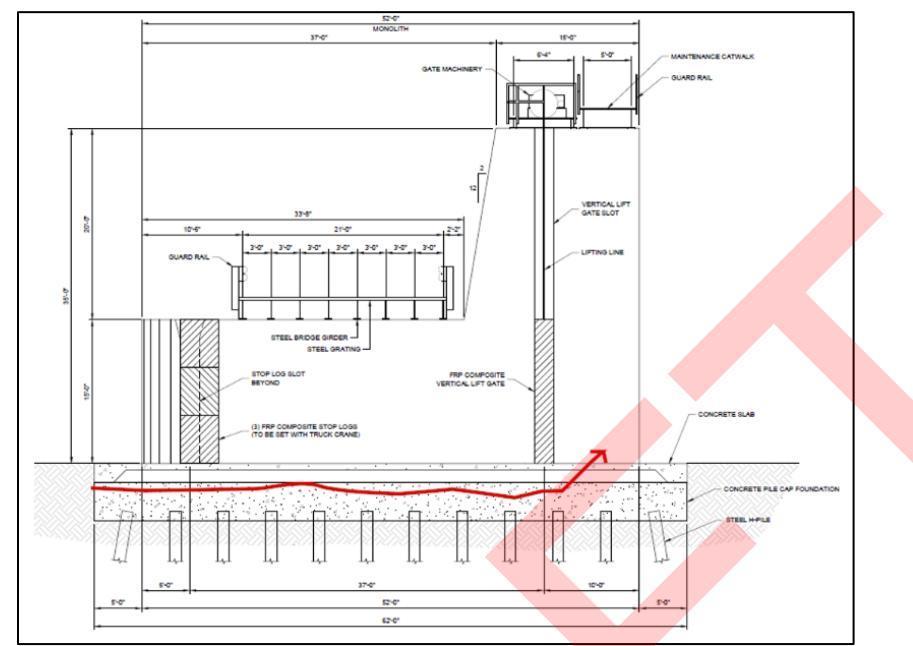
Figure 50 shows the CLE failure path for this PFM that could potentially occur by initiating through an open joint in the gated structure, when the gates are closed and there is a head differential across the structure. This PFM could not be evaluated at this level of design; however, the design should include water stops at all cold joints and construction best practices should be monitored with good quality control. Additionally, as it pertains to the foundation, if differential settlement is not addressed there lies the potential for cracks to occur at joints or other places; however, given the dam foundation has been surcharged by the existing fill, differential settlement is not expected to be significant.

Figure 50 – Failure path for CLE between sheetpile and concrete cap.

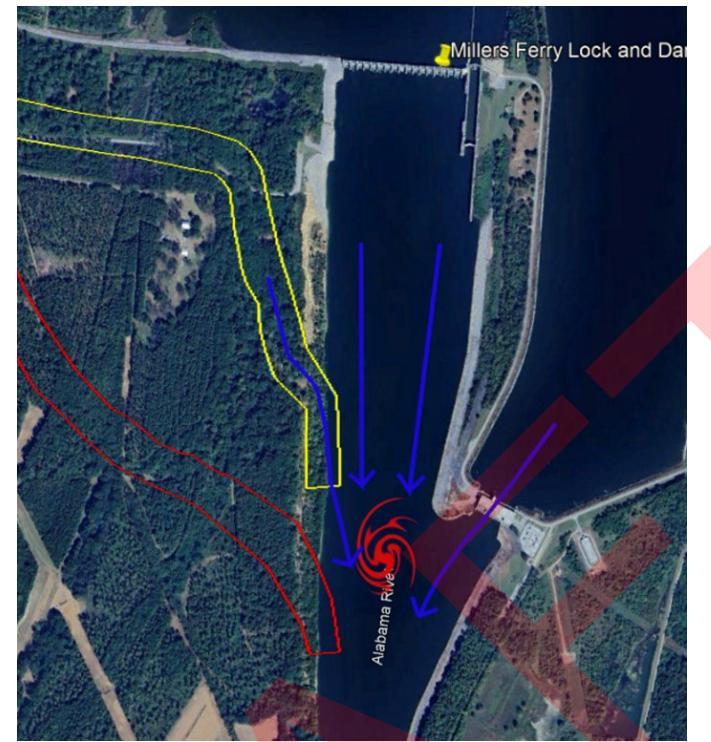
The fish ladder proposed alignments have a flow of 1,200 cfs exiting into the main river channel, creating a confluence of multiple channels which could result in bank erosion from the eddies, illustrated in Figure 51.

The Powerhouse located on the east side of the river has average discharge flows between 20,000 and 30,000 cfs. The powerhouse discharge capacity is 34,000 cfs with 3 units running. The flow of the fish ladder channels is so much smaller than the powerhouse discharge flows into the river. The east bank downstream of the powerhouse has existing riprap armor for scour protection from powerhouse releases. The normal operations flow through the powerhouse and the spillway is only used during times of high pool; therefore, the majority of the time there will only be confluence of two channels, the fish ladder and the powerhouse. The flow of the fish ladder channel is insignificant compared to the flow generated downstream from the powerhouse. For this PFM to get to failure, the turbulence must be large enough to erode the armoring on the eastern bank. When the spillway does overtop, the powerhouse discharge would still drive the design. This PFM was excluded as a risk driver because the river downstream of the dam is already designed for high velocities from the powerhouse.

Figure 51 – Confluence of multiple channels resulting in eddies.

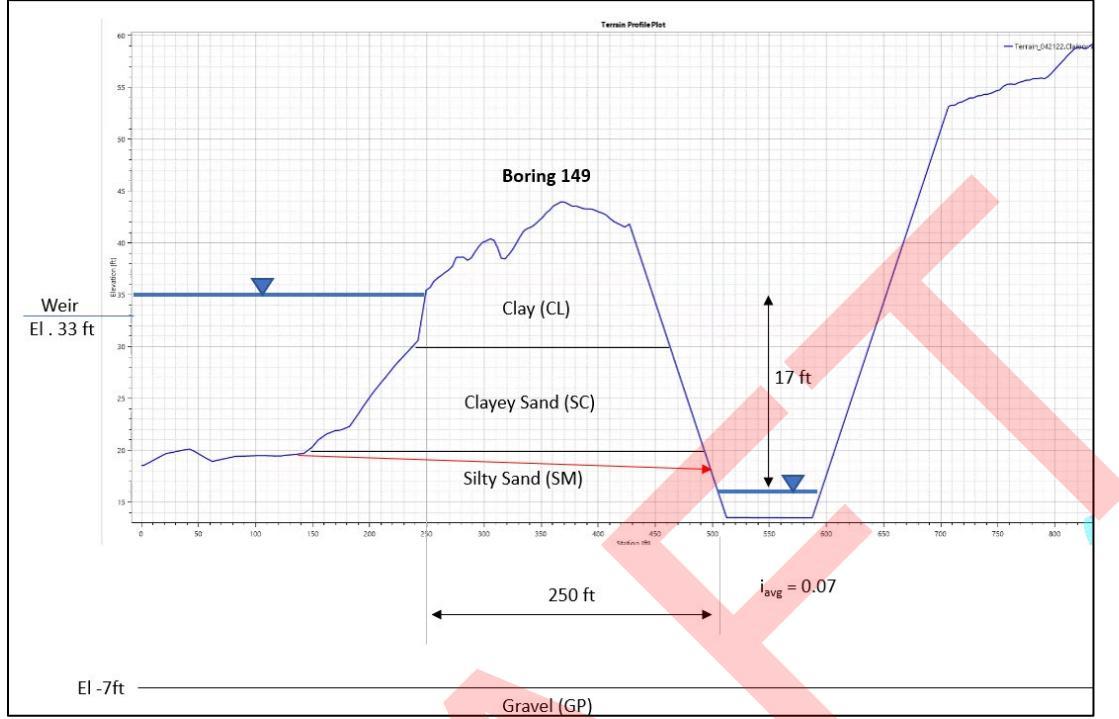
Description: The falling elevation of the bypass channel results in a head differential between the water behind the main dam and the water elevation in the bypass channel. A continuous erodible sand is exposed by the channel excavation with horizontal seepage exit into the new cut. Gradients are high enough to initiate erosion at the unfiltered exit and piping begins to progress back towards the Alabama River. Clay or clayey sand holds a roof for mechanical progression. There is sufficient flow in the developing pipe for progression and the pipe progresses to a connection with the river, leading to collapse of the embankment. This allows for overtopping to progress the breach. Figure 55 shows a LiDAR cross section of existing topography with the proposed channel added. The failure path is shown on this figure along with the expected geology based on the limited boring data (from boring 149).

The most likely location selected for this PFM is directly adjacent to the dam. At this location, the highest head differential will exist, where the headwater is controlled by the dam while the fish channel is dropping in elevation around the edge of the dam. Additionally, there is an existing sheetpile cutoff wall under the structure in the right abutment that will back up seepage and force seepage to discharge to the west around the side of the wall, and into the channel. Figure 56 illustrates this concept and the potential for more concentrated seepage that could exist around the edge of the existing sheetpile cutoff wall.

Figure 55 – Lidar cross-section with hydraulic head condition and subsurface conditions at the PMF location.

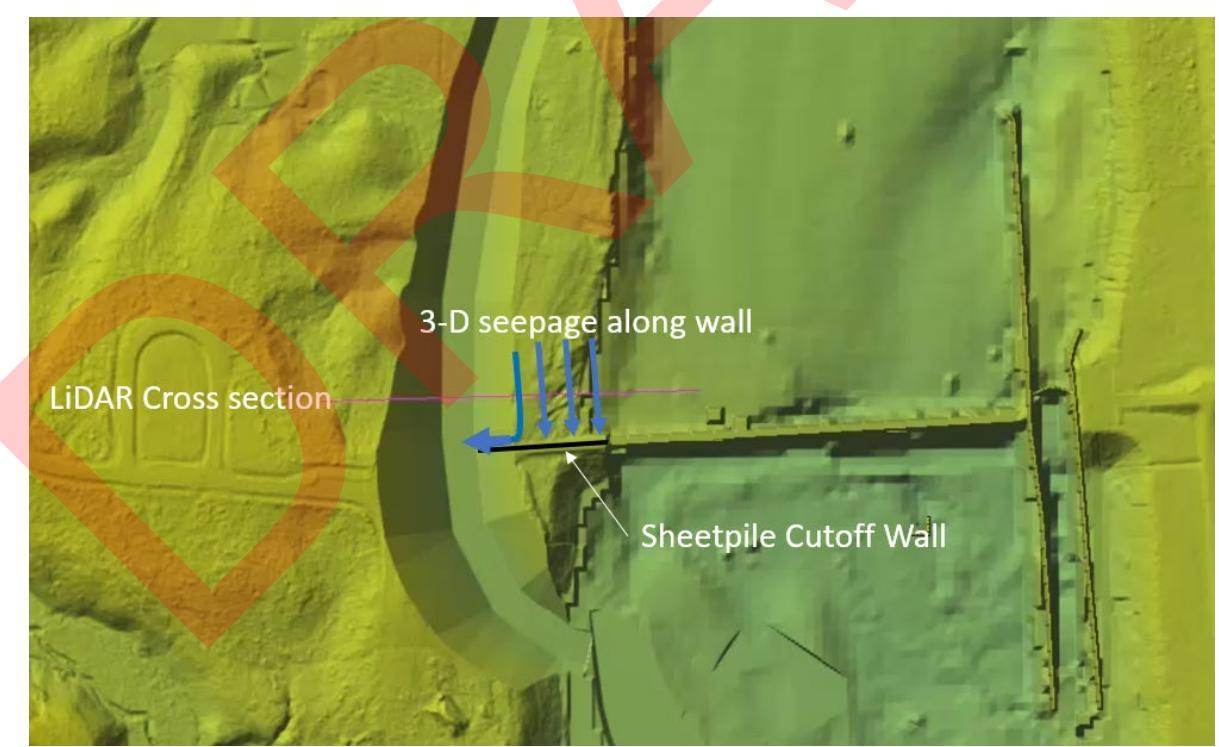
Figure 56 - LiDAR topography with location of cross section cut for PFM.

The current alignment would result in an approximate 250 ft seepage path with approximate 17 ft head differential on a normal sunny day condition (average gradient of 0.07). Less frequent events would cause higher tailwater and would be less likely to initiate and pipe. There is only one soil boring available which shows a silty sand being present near the invert of the river. This allows hydraulic connection to the sand layer in the river and the fish ladder canal would cut into this sand allowing for potential horizontal exit of seepage through this layer. There are no fines content tests to support decisions on how erodible this material would be to piping, with an SM with 40% fines not being susceptible to piping, while a silty sand SM with 15% fines could be susceptible at this gradient. Additionally, the presence of the existing cutoff wall under the dam will cause seepage to concentrate and flow laterally around the end of the wall, increasing the likelihood of initiation and progression at this location. The CL materials above the sand layer are very likely to provide roof support. Schmertmann analysis making gross assumptions shows that if a low Uniformity Coefficient (Cu) sand were to exist in this area, progression probability would be on the order of about 3E-02. Given the AEP of the event is 1 (occurring annually and existing for long sustained periods of time), roof support exists, sands are likely continuous across this width, then the APF for the scenario documented here will likely be controlled by the progression node of the event tree. Based on these factors, this PFM is judged to be a potential risk driver if an erodible sand layer is confirmed along the fish ladder alignment.

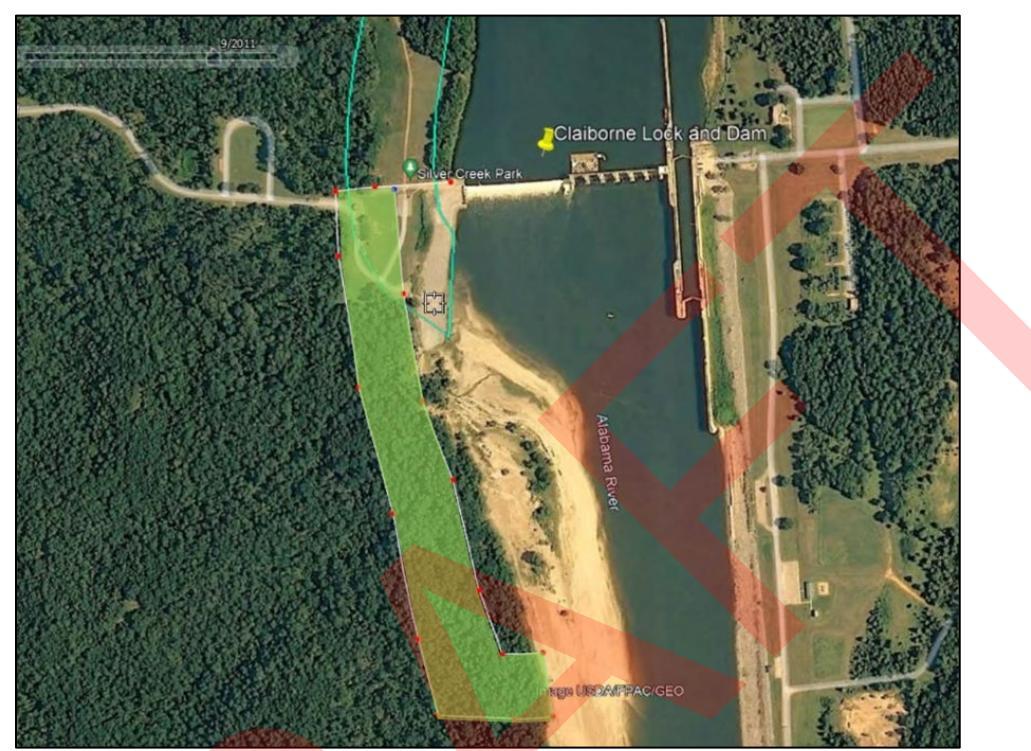
Figure 57 – Alternative to construct channel in line with crest and extend further south.

57. This would move the entrance gate of the bypass channel to be in line with the dam and eliminate the land mass between the gate and existing right abutment. This would be a similar design to Millers Ferry fish ladder bypass.

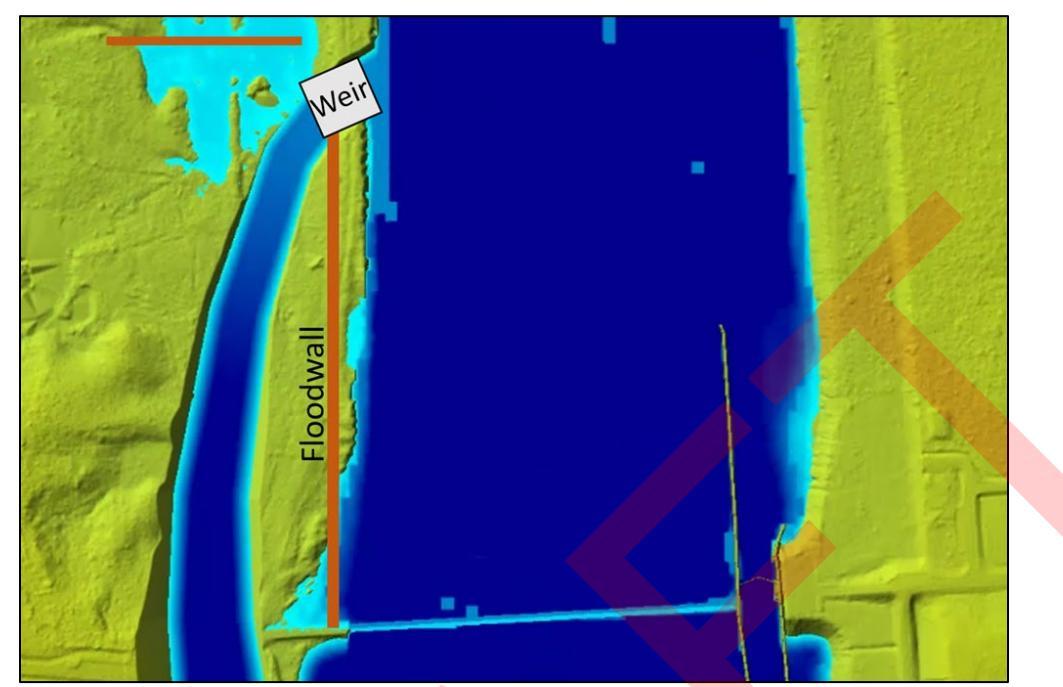
Figure 58 – Alternative to construct a floodwall and connect to higher ground.

The second measure identified would construct a floodwall along the new right abutment damming surface to reinforce the island and connect to higher ground shown in Figure 58. The proposed alignment of the floodwall would include a cutoff to address BEP.

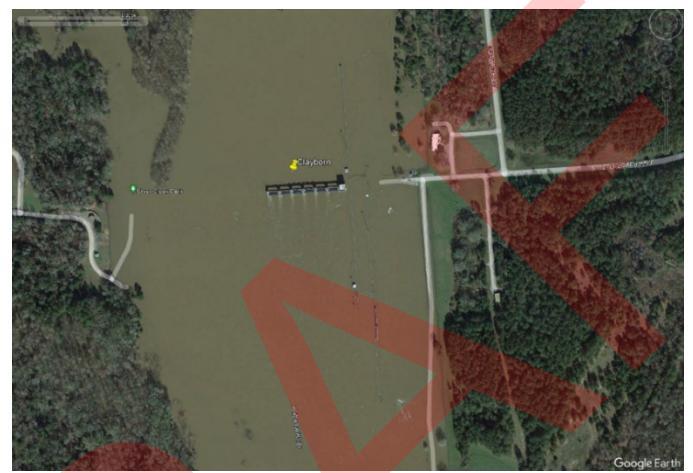
The Claiborne Dam is designed to overtop and overtops most years as seen in Figure 59 from google earth historical imagery. The project is primarily for navigational purposes and there are no flood risk management benefits from the project.

Figure 59 – Google Earth historical imagery showing overtopping of Claiborne L&D.

The upstream fixed crest weir is at elevation 33.1 ft, to match the elevation of the ungated spillway. Therefore, the construction of the fish passage channel will not increase the frequency of overtopping of the dam. Therefore, this PFM was excluded as a risk driver.

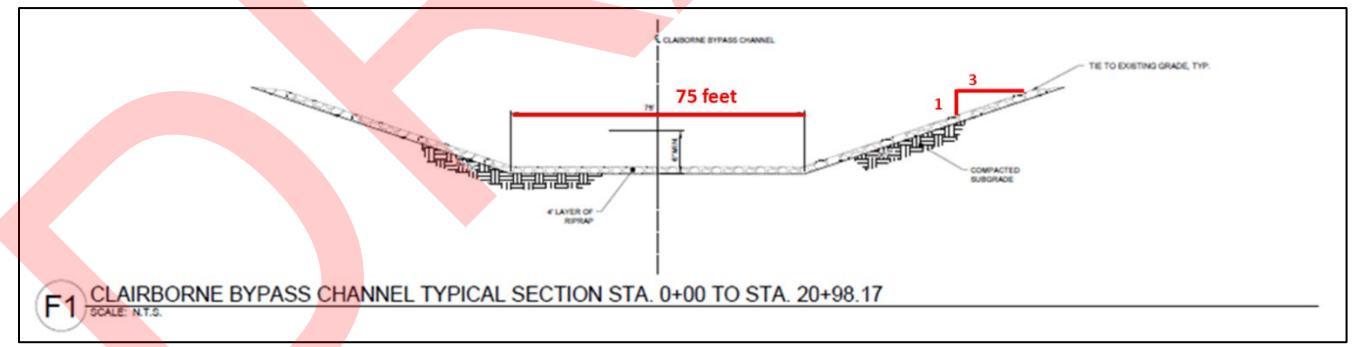
Figure 61 – Fish ladder channel typical section.

The design team proposes 3-D hydraulic modeling or CFD modeling to better understand the flows within the channel as well as the interaction as the water meets the tailwater at different elevations to understand how the out of bank flow interacts with the channel. The design will include appropriately sized riprap or can use grouted riprap to create weir pools throughout the channel. Figure 61 shows a typical section that includes riprap protection along the channel invert. This PFM cannot be fully evaluated at this time without more suffocated hydraulic models to predict maximum velocities; however, it was excluded given that the feasibility design includes armoring along the channel invert to prevent scour erosion.

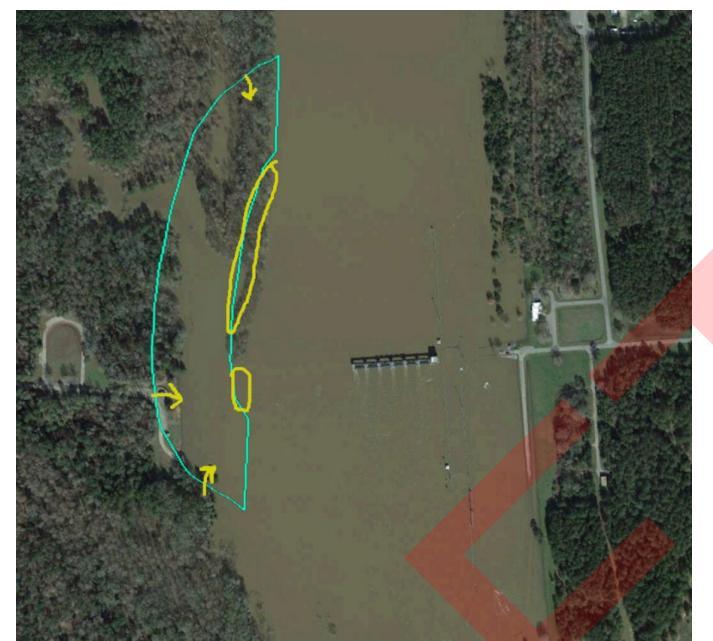
A rapid drawdown after a highwater event results in receding water of approximately 3.5 feet per day (e.g., January 2016). As the water subsides, the earth embankment is slow to release the pore water pressure, resulting in instability of the slope. The most vulnerable slopes include the right abutment sliding into the channel or river, the upstream island failing, or the western slope of the channel failing into and blocking the channel illustrated in Figure 62. Higher banks on the eastern side of the fish ladder channel could make slope instability more likely where the proposed channel slopes are 3H:1V.

Figure 62 – Slope failure into channel with out of Bank flows.

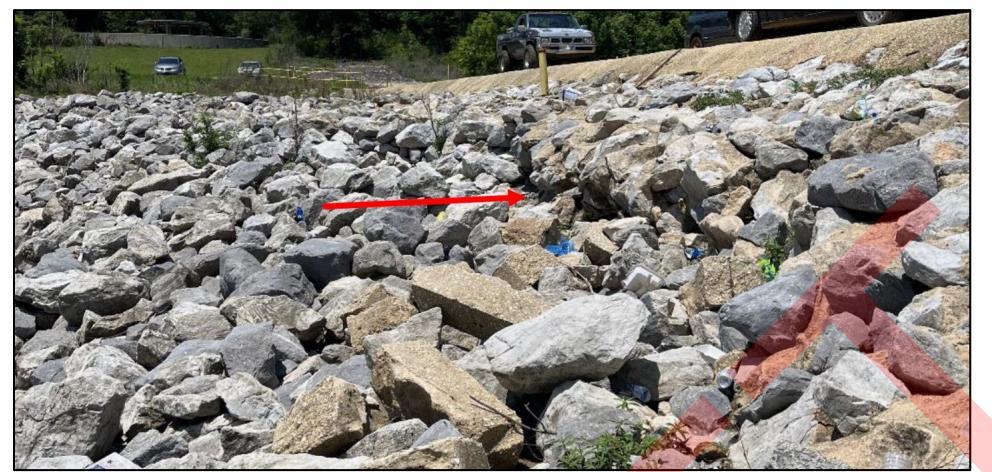
Historically at this project, this type of highwater event occurs more frequently than a 1/15 AEP event, and slope failures have not been observed along this bank. However, movement has been noted in the annual inspection where the riprap meets the grouted riprap shown in Figure 65 along the downstream stope adjacent to the right streambank; however, it is uncertain if the shelf observed in the photo is a separation from the

grouted riprap or a sloughing of the slope. Further evaluation during PED is necessary to exclude this PFM, with the design recommendations above and in PFM 02.

Figure 65 - Sloughing where grouted riprap meats the riprap.

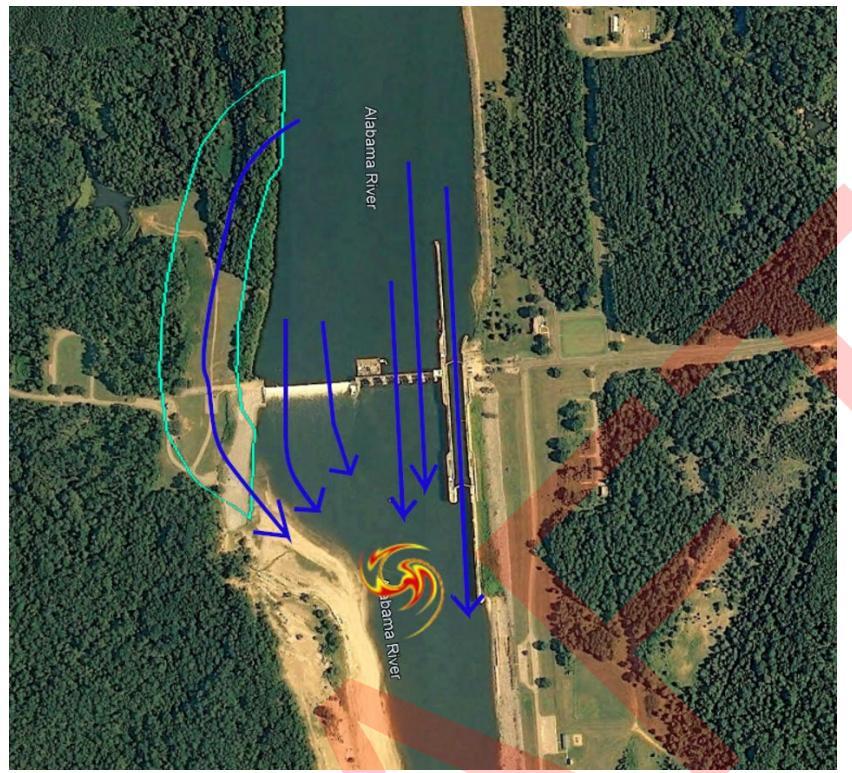
The addition of the fish passage channel creates a confluence of multiple channels resulting in bank erosion from the resultant eddies shown in Figure 66. This PFM was excluded as a risk driver because the river downstream of the dam is already designed for high velocities that are experienced regularly. This PFM may present itself as a maintenance issue with the dredge spoil location adjacent to the canal. Additional modeling is recommended to identify and address any locations which may need armoring.

Figure 66 – Confluence of multiple channels causes eddies.

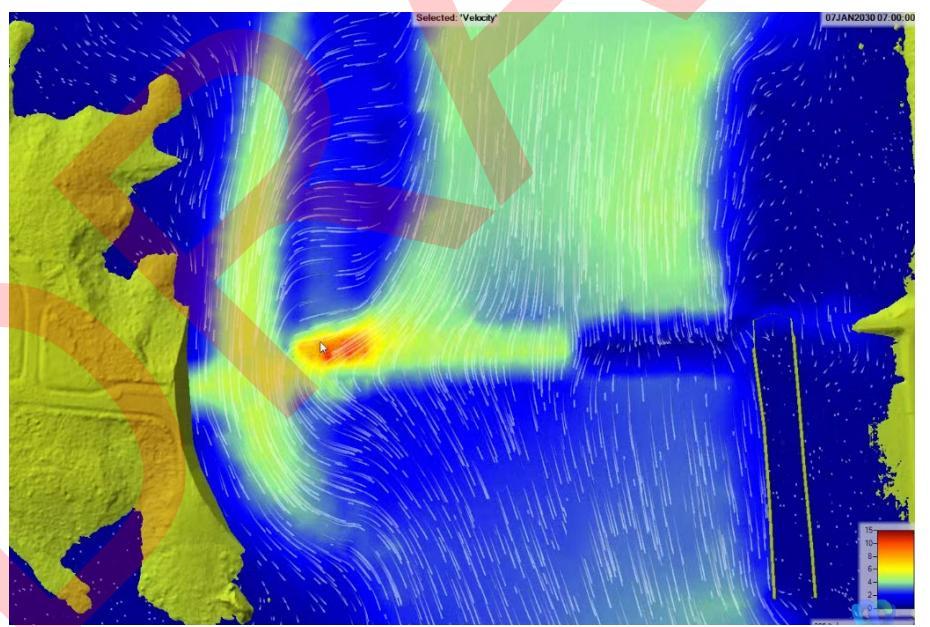
During construction, a high-water event occurs causing overtopping of the temporary cofferdams and/or the low point within the island between the channel and river. Bed scour of the channel after completion is reliant on rip rap and other materials to be placed controlling the velocities and erosion anticipated. Figure 67 shows a flood model with a 1/500 AEP event showing 4 to 7 fps in the channel. It should be noted that this model is smooth with a 1 percent slope; whereas the actual construction will be a series of steps that will have drop structures with additional turbulence introduced. These materials may not be in place when the high-water event occurs during construction. Erosion begins similar to an overtopping breach into the partially excavated channel. This bypasses the existing dam's spillway and will allow for uncontrolled release of water.

Figure 67 – Flow model shows potential for turbulence in the channel.

Staged phases of construction should be implemented to reduce the likelihood of this PFM. The island should be constructed to dam standards up to El. 40 ft along with the construction of the upstream weir, and stop logs installed or gates closed. The western edge of the channel weir is also tied into higher ground as a damming surface.

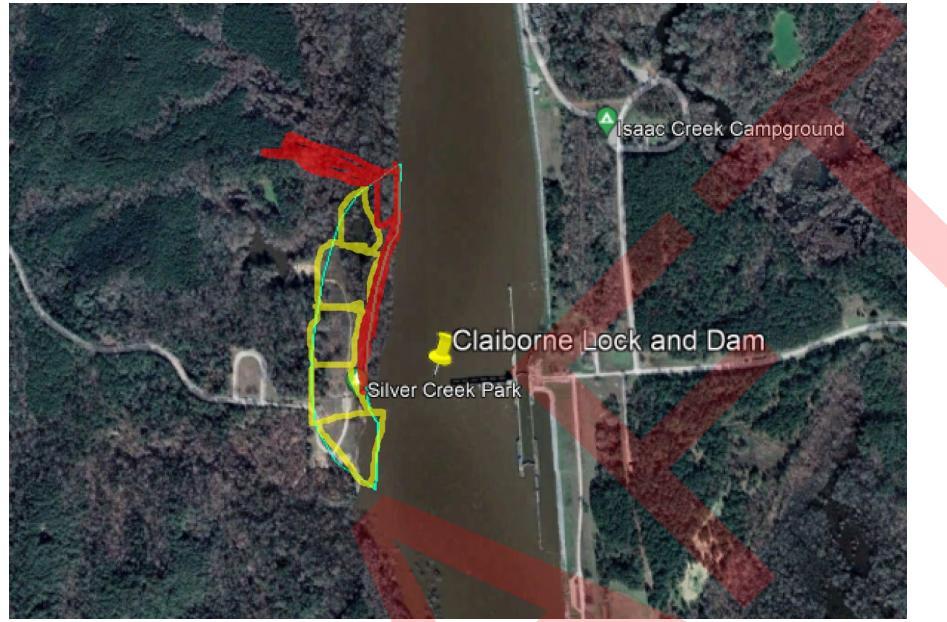
Construction of the channel will start from north to south and completed with armor in cells or sections no longer than 450 feet before starting the next cell, repeating until the channel is complete. This phased construction is illustrated in Figure 68. This may incur additional construction costs, especially if multiple mobilizations are required.

Figure 68 – Construction of the island broken down into phases.

This sequence of construction allows for protective measures until the channel is complete and minimizes damage as well as the potential for this PFM to progress. There may be alternate methods of controlling this PFM that should be evaluated for dam safety during PED.

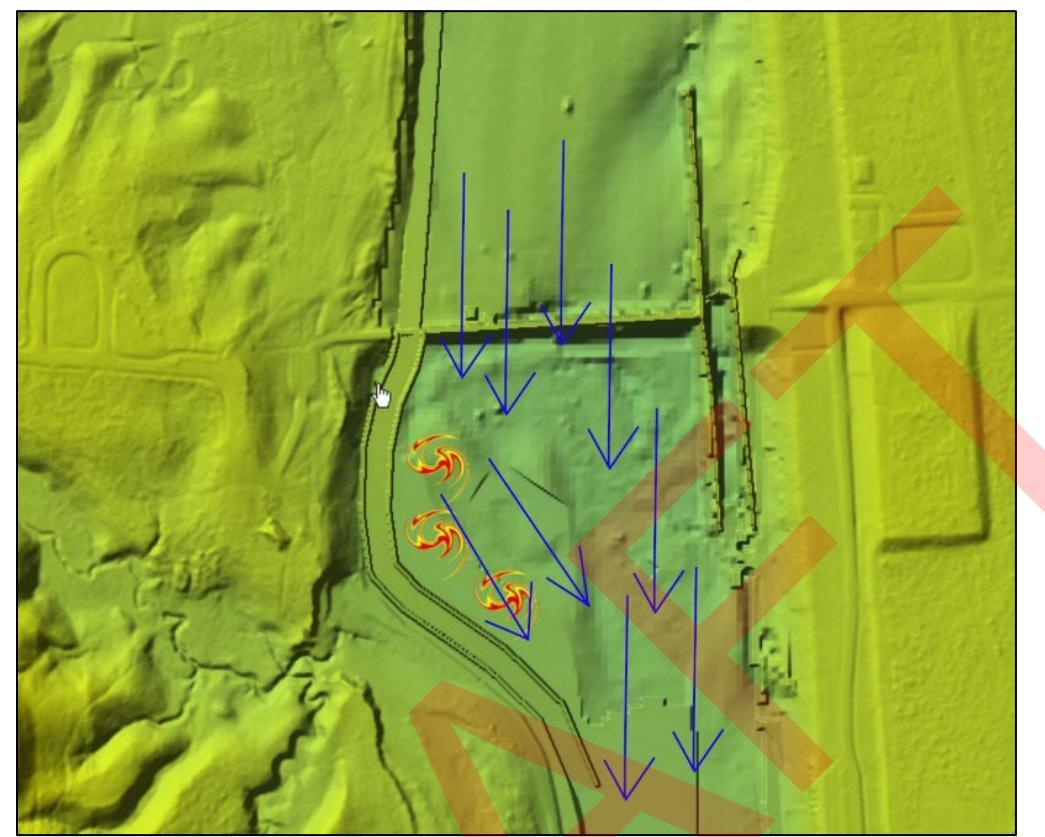
Description: Flow through the gated spillway and over fixed crest spillway creates eddies that cause fill material under the concrete channel to erode from scour, leading to differential settlement and tilting of the fish ladder. This causes water to short circuit the fish ladder weir resulting in loss of function. This PFM is illustrated on Figure 71.

The velocities are currently estimated on the order of 7 to 8 fps downstream of the structure. Permissible velocities are on the order of 5 to 7 fps for a compacted clay fill material that is expected to be under the new structure. The PDT is aware of the potential undermining and plan to include riprap and scour protection on the slopes based of velocities from CFD modeling to determine riprap size. This PFM is a loss of service and not a dam safety issue; however, given the 40 ft depth of fill needed to support the structure and the fact that the u-shaped concrete structures will be founded on this fill, there is high potential that any scour erosion could cause tilting of the structures. This would cause unbalanced flow down the fish ladder and will reduce to preclude benefits of fish passage. Therefore, it was identified as a loss of service risk driver for this alternative that is not addressed by the conceptual design.

Figure 71 –Eddied currents that may cause scour along the fish ladder passage.

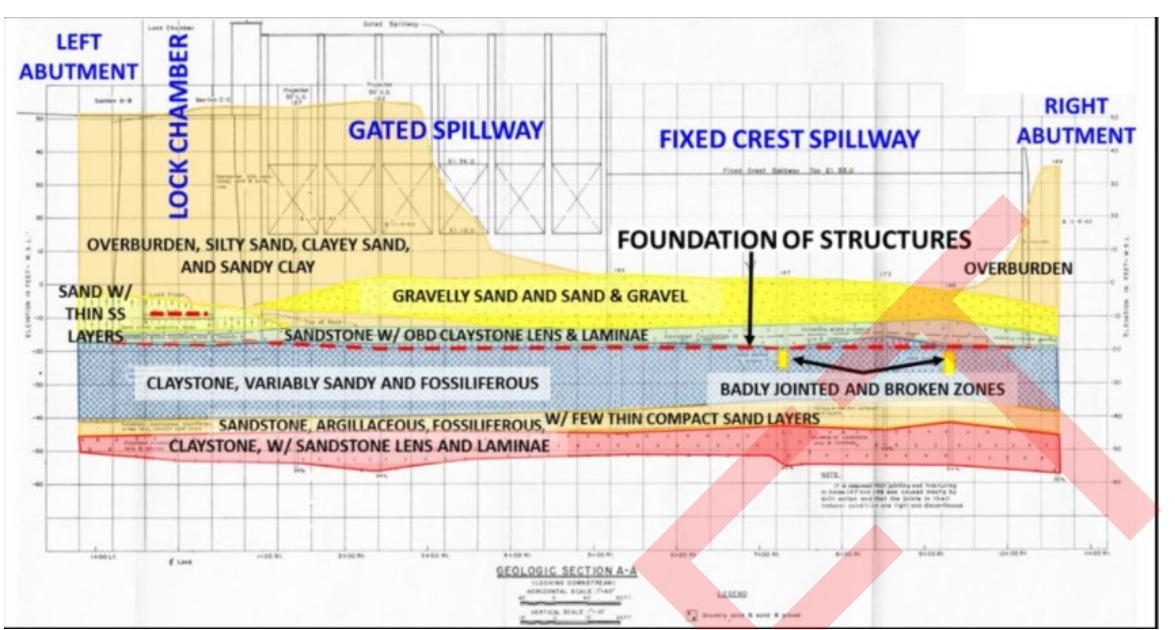
Currently in this phase of the design, a fill source has not been identified. If the material is clay, there is likely to be some meaningful magnitude of primary and secondary consolidation over the service life of the project. The fill material will likely be placed directly on bedrock shown by the cross-section in Figure 72; therefore, there will be no significant magnitude of settlement expected from the foundation. However, at 40-ft in fill height, even with good compaction there will be some settlement of the clay fill.

Figure 72 – Geologic cross-section showing overburden soils and weak rock above foundation grade (red dashed line).
