# Claiborne and Millers Ferry Locks and Dams Fish Passage Study

SUBJECT: Potential Failure Mode Analysis and Screening-Level Risk Assessment – Claiborne and Millers Ferry

# Screening-Level Risk Assessment Claiborne and Millers Ferry Fish Ladders

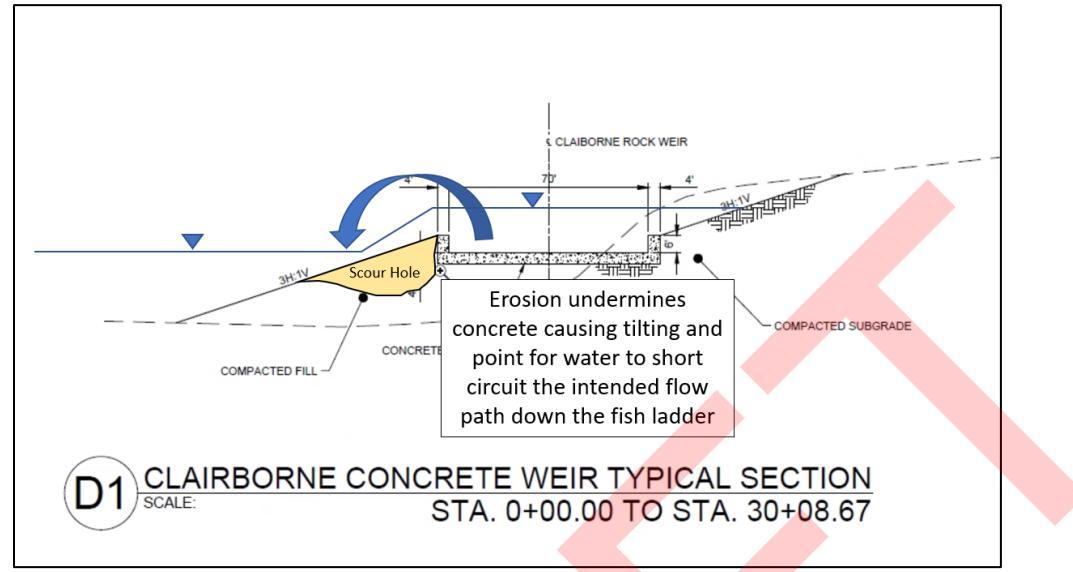
Figure 74 – Cross-section showing the undermining of the slope protection.

This PFM is not a dam safety concern because blockage of the channel would not lead to failure of the dam; however, a debris blockage would lead to loss of function of the new structure. This PFM was judged to be a risk driver for the project that is not addressed by the current conceptual design.

For all three of the risk drivers identified below, the team brainstormed modifications to the design that could address these PFMs. Due to the flow velocities around the structure from the river and due to the potential for settlement and debris jams, it is recommended that if this alternative is further developed that it be modified to include a foundation that extends to bedrock to prevent movement of the structure due of undermining of settlement.

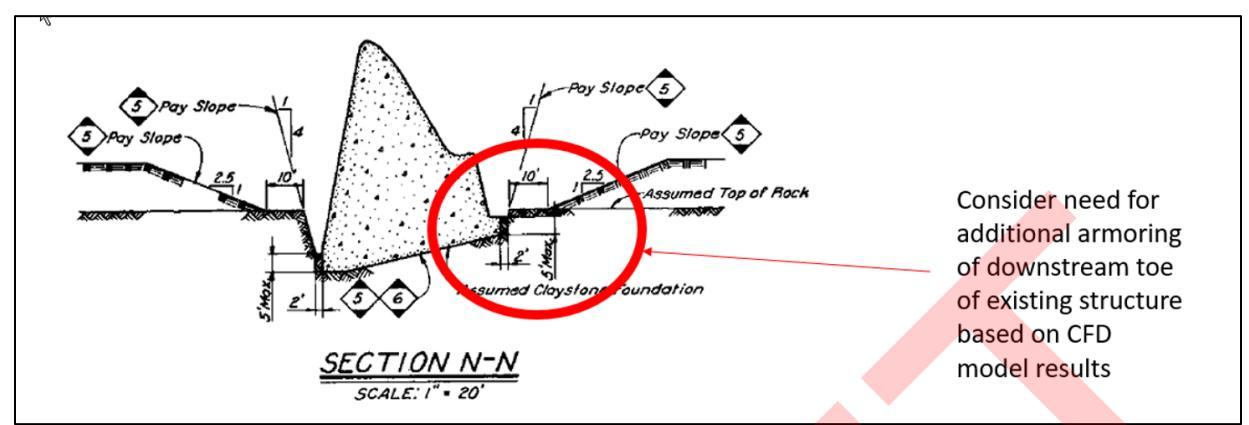
The new structure will change the hydrodynamics downstream of the dam, which could cause higher velocities that have been historically acting on the structure. These higher velocities could induce erosion in new places that could cause scour and differential movement of the existing dam.

The dam is founded on claystone which should be erosion resistant to the velocities that could occur in the river and therefore this PFM was excluded; however, CFD modeling should still be performed to verify velocities that could occur because of the modification. The PDT recognizes that accurate CFD modeling would better predict the change in flow and help determine the size of armoring needed to prevent scour at new and current structures. The foundation is described as being a claystone with also variable sandy and fossiliferous zones which may be more susceptible to erosion.

Figure 75 – Additional armoring of existing structure.

The team recommends an appropriate analysis be performed to see if potential scour will occur from a change in hydrodynamics due to a new structure in the channel and to appropriately place a concrete apron or riprap armoring where needed (e.g., downstream toe shown in Figure 75) as well as verify cost estimates to capture potential need for additional armor material.

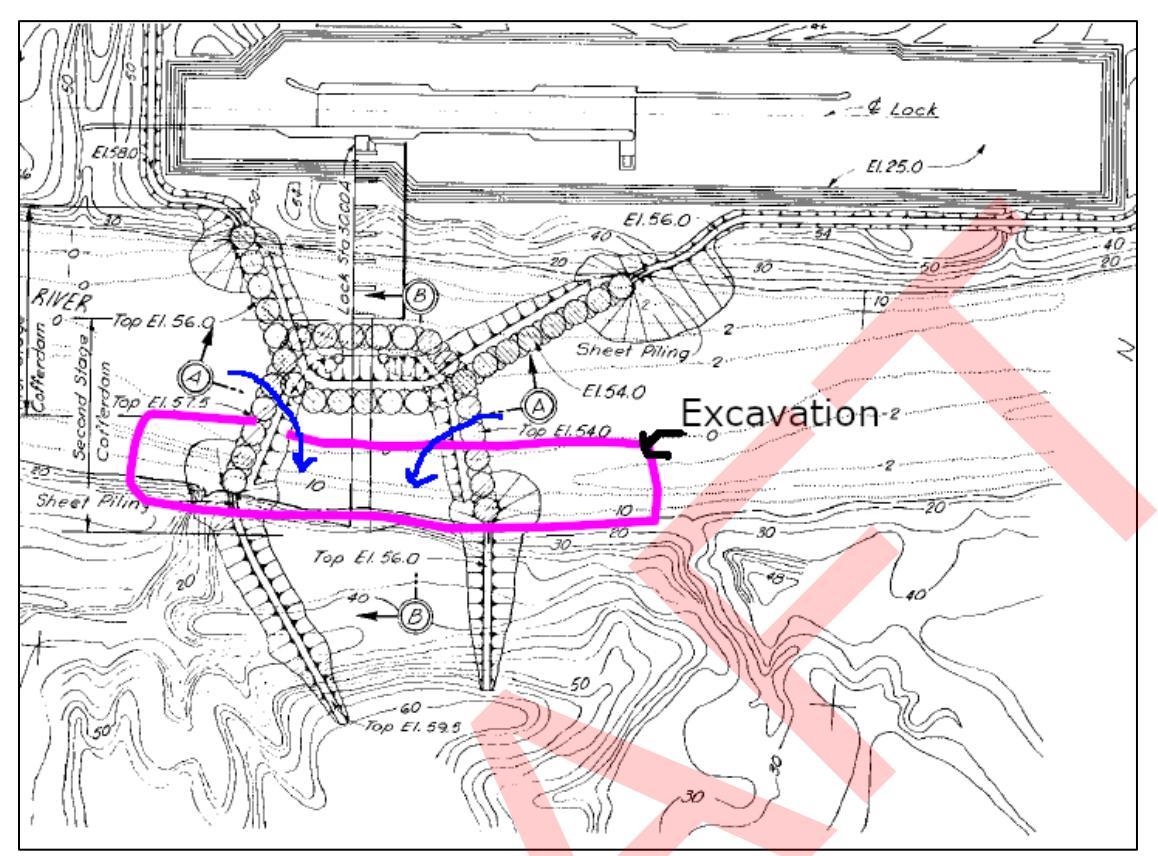
Construction techniques have not been identified at this phase of construction to mitigate scour potential in the event of overtopping. It is assumed that excavation will be down to bedrock and the fill material will be placed on top in unison from upstream to downstream for the concrete fixed crest spillway. The top elevation of the cofferdam during original construction was at El. 54 or 57.5 ft MSL. In the event that overtopping occurs, the contractor should have 4-5 days advance warning based on past floods to prepare the construction area and fill the area with water to prevent scour from overtopping. At the time of the risk assessment, this failure mode could not be fully evaluated.

### Figure 79 – Area of excavation for new structure.

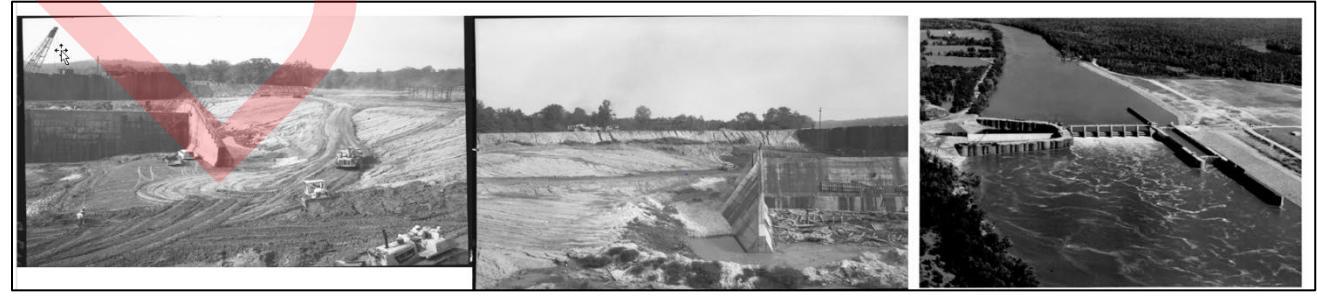
Figure 81 – Construction of fixed weir leading up to the cofferdam.
