# STRUCTURAL ASSESSMENT REPORT BUILDINGS 06 & 07

## HISTORIC BUILDING STRUCTURAL ASSESSMENT

1014 & 1018 WATER AVENUE SELMA, AL 36703

**14 FEB 2025**

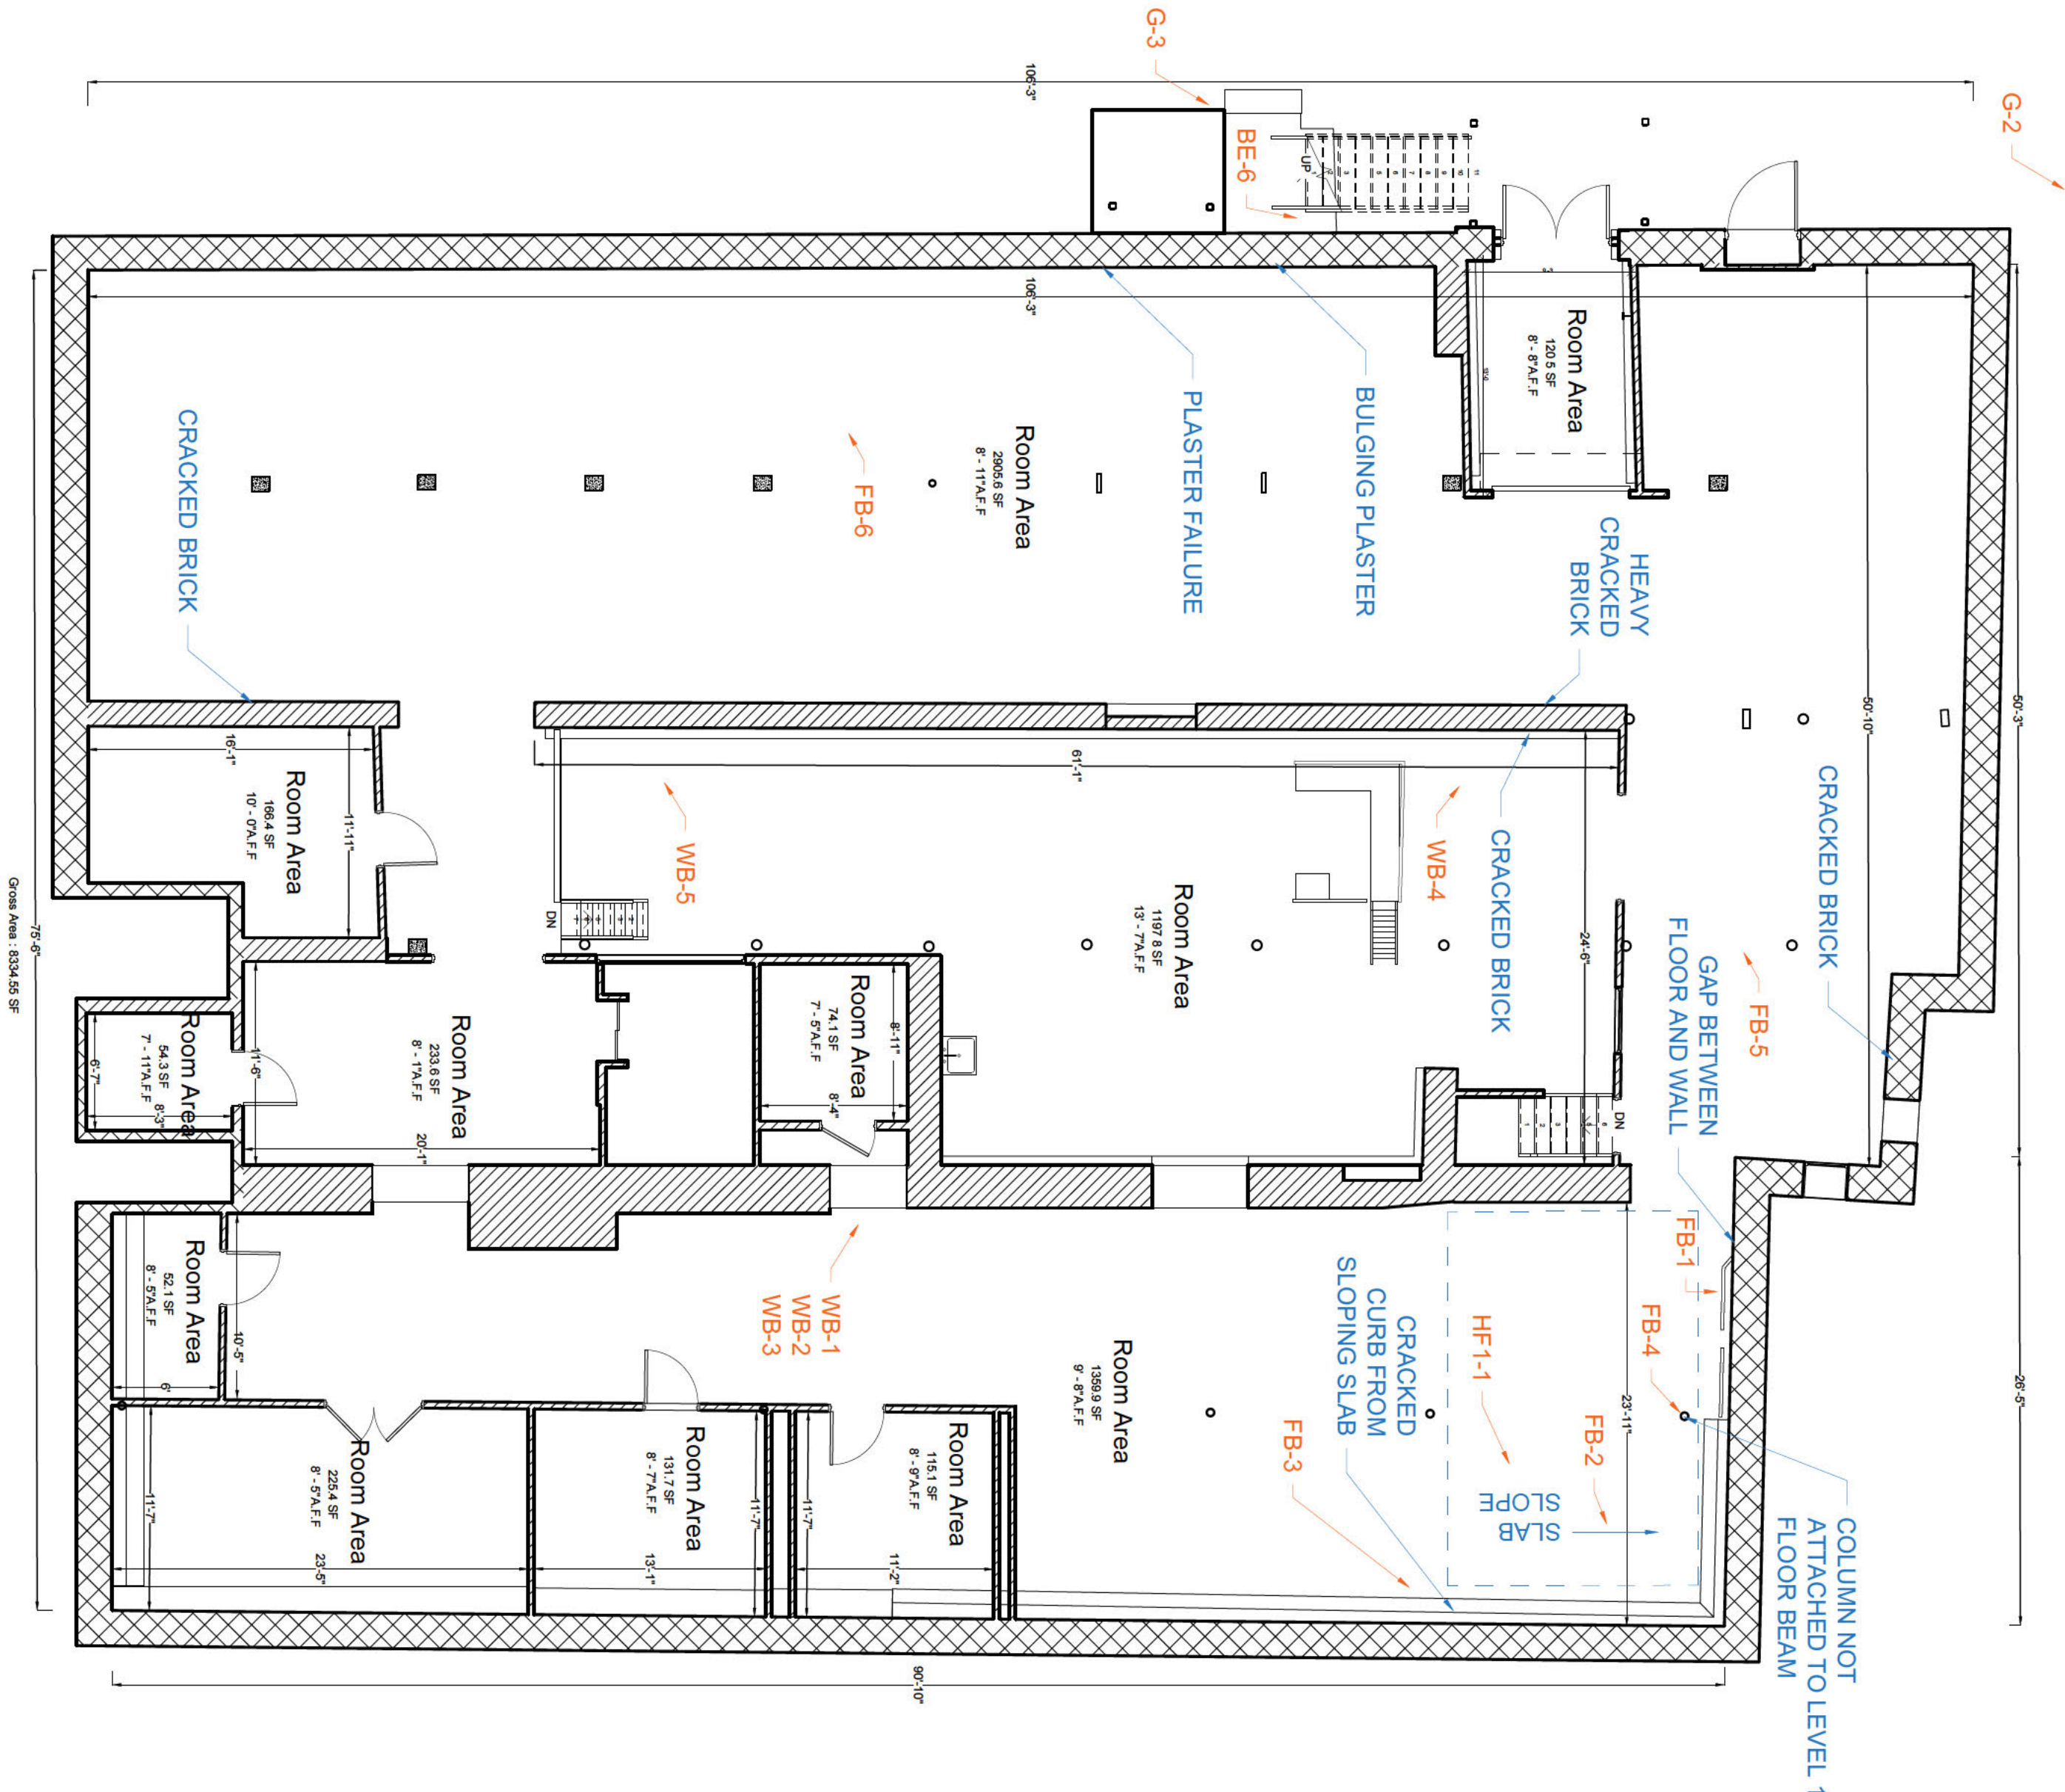
A1  
S-101  
SCALE: 1/8" = 1'-0"

FB-3: Basement, crack in kneewall on the west wall

FB-5: Basement, minor cracking in basement grade slab on south side

FB-6: Basement, minor cracking in basement grade slab on east side

WB-1: Basement, small stairstep crack in west interior wall

WB-2: Basement, brick repair on west interior wall

WB-4: Basement print room pit, crack on east wall of pit

WB-5: Basement print room pit, Crack on west wall of pit

WB-6: Basement print room pit, crack on west wall of pit

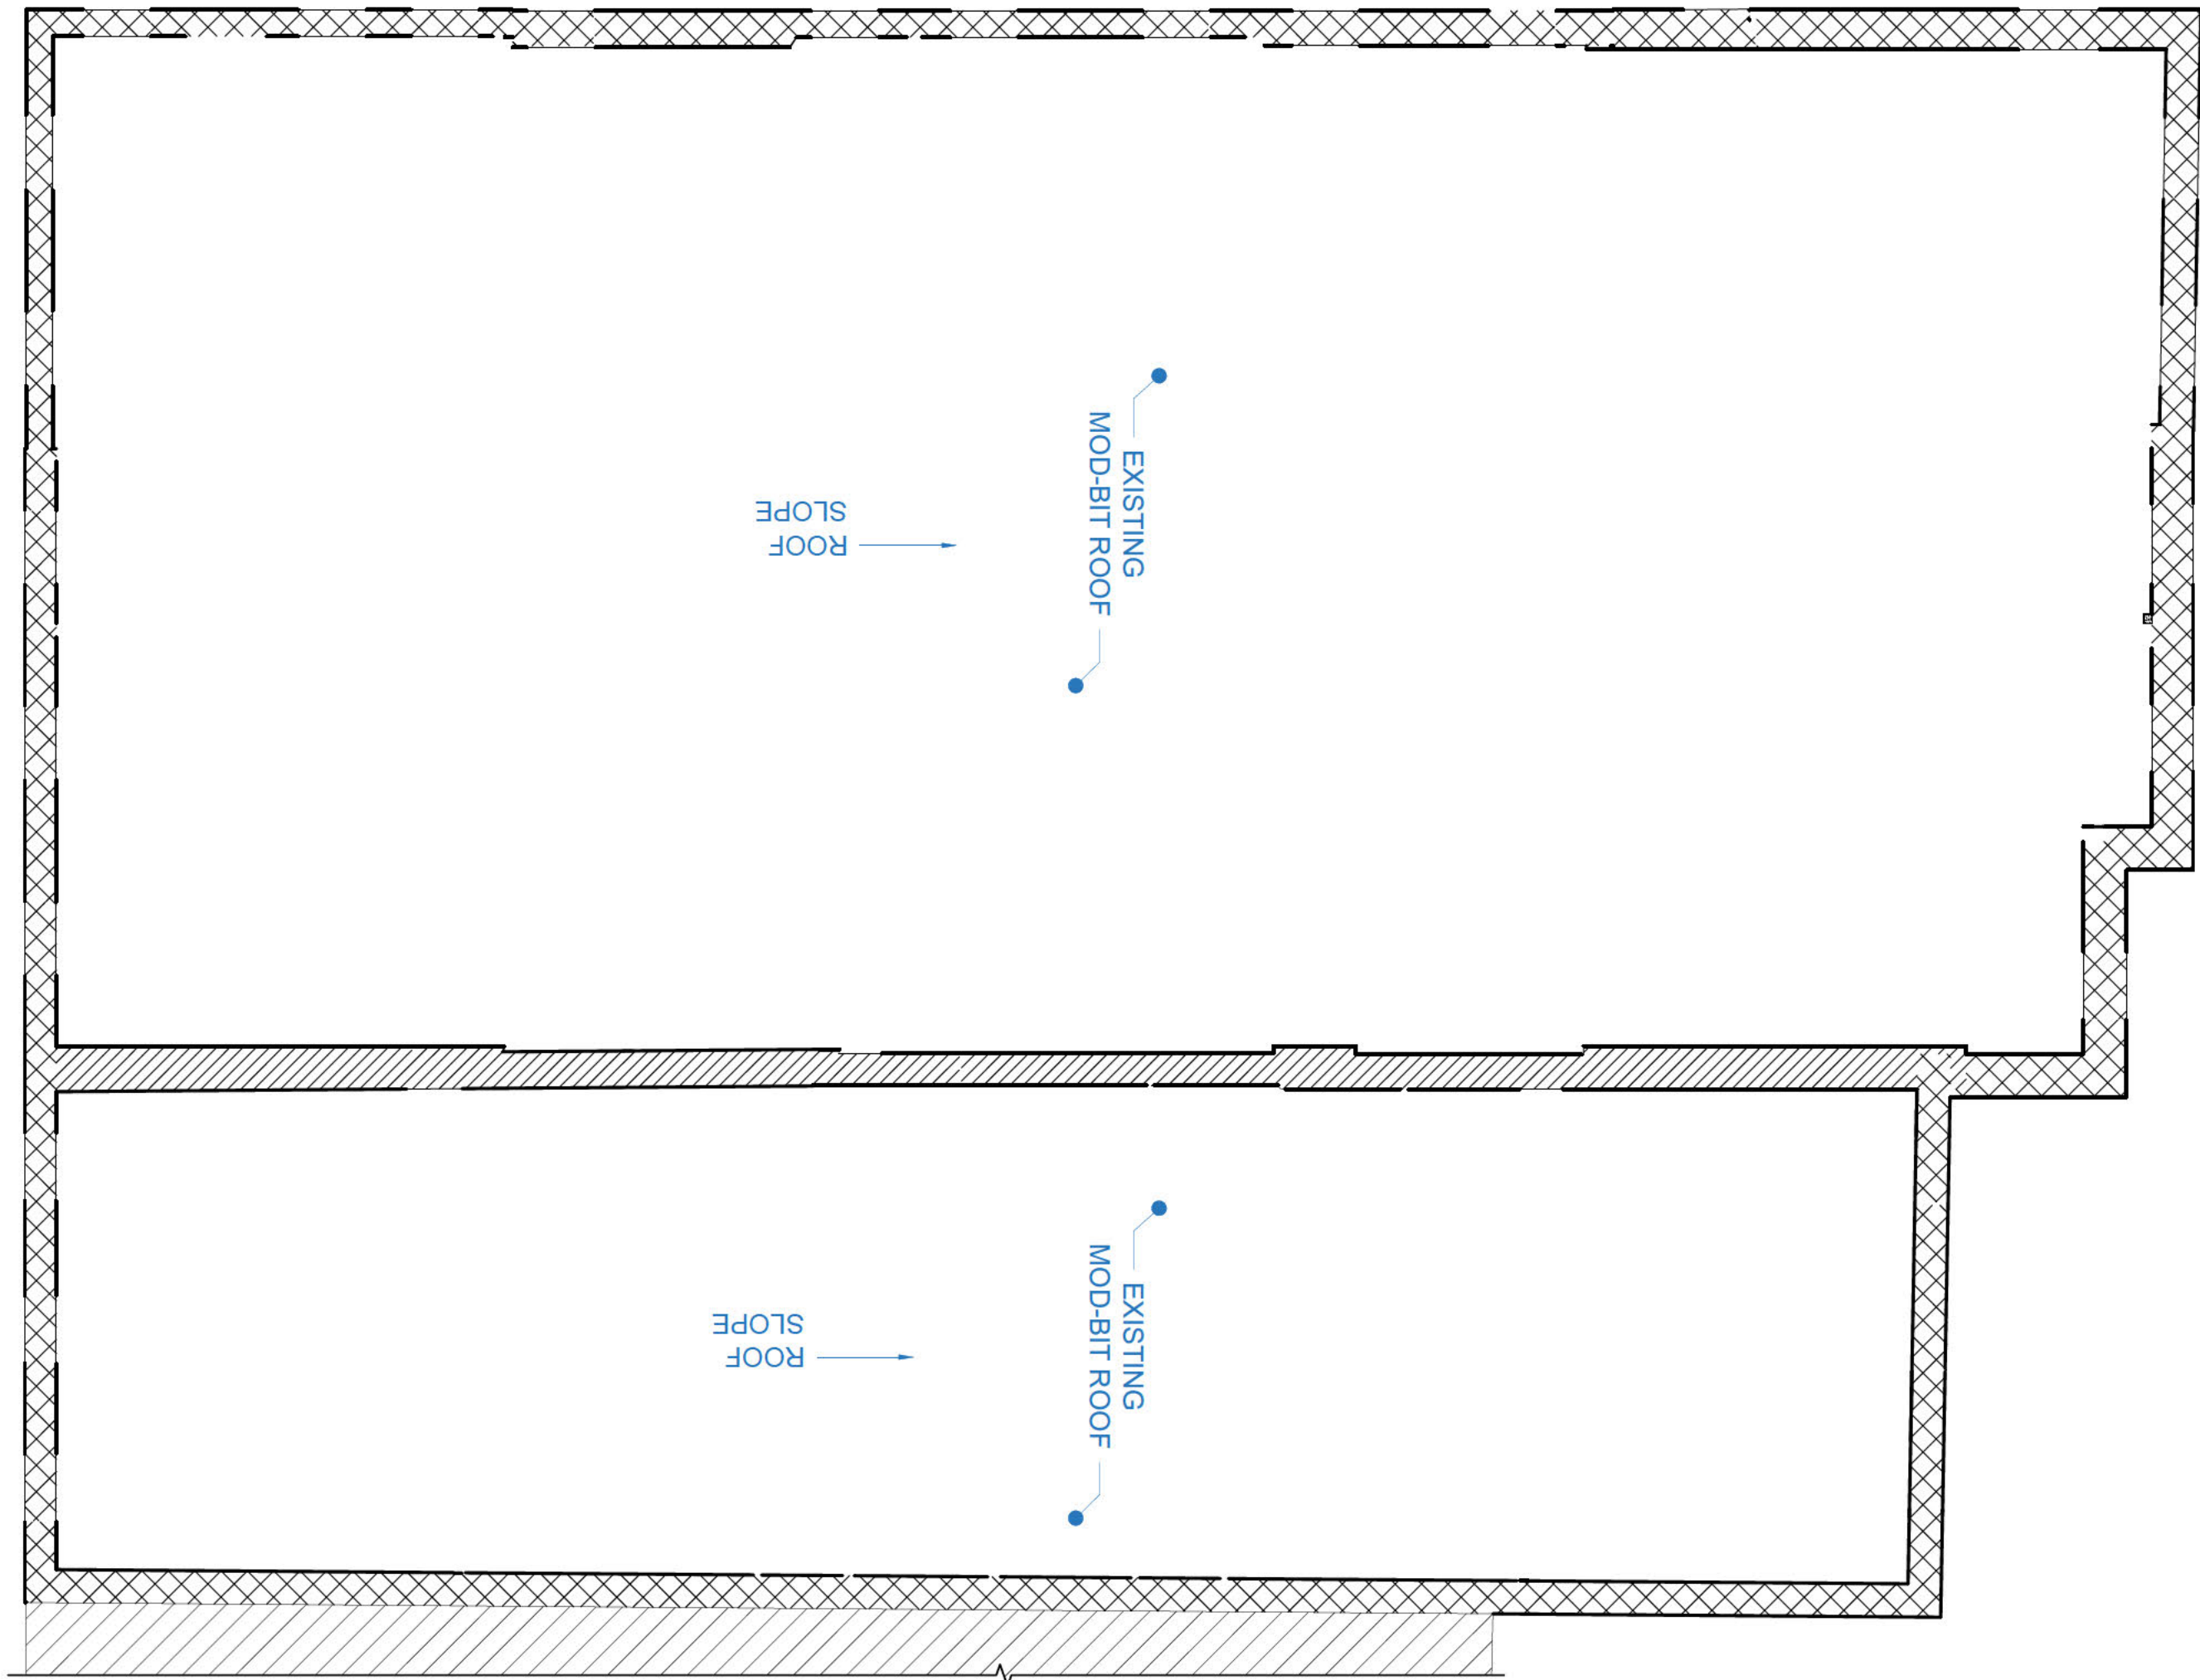
\*\*ROOF NOT ACCESSIBLE DURING STRUCTURAL ASSESSMENT
