PART I. EXECUTIVE SUMMARY

The City of Rome, Georgia is located at the headwaters of the Coosa River. Rome is the county seat of Floyd County and is approximately 73 miles northwest of Atlanta, GA and approximately 90 miles south-southeast of Chattanooga, TN. Floyd County is located in the northwest area of Georgia along the Alabama-Georgia state line and Rome is approximately 25 miles east of the Alabama-Georgia state line. The Etowah and Oostanaula Rivers merge to form Coosa River in downtown Rome near the center of the levee system.

The levee project was originally constructed in May 4, 1938 and completed on February 17, 1939. A Flood Control Project was authorized by Section 5, Act of Congress (Public No. 738-74th Congress), authorizing the construction of certain public works on rivers and harbors for flood control and for other purposes, which states, under Mobile River Basin, "Rome Georgia: Levees on Coosa River to protect people and city property; special report on record in Office of the Chief of Engineers; estimated construction cost, \$330,000."

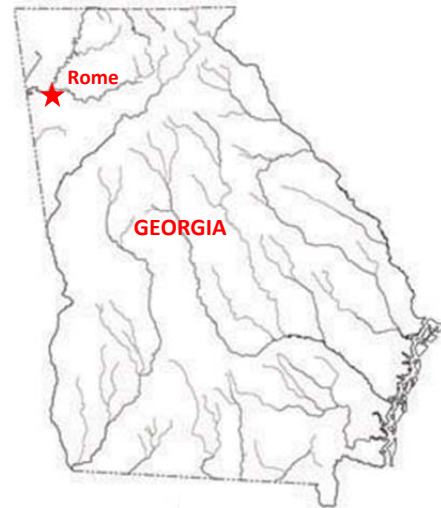
The protective work forms a U-shaped loop around the Fourth Ward of the city and connects with high ground at both ends. Before the completion of the project, stages in excess of 28 feet on the Rome gauge would inundate parts of the Fourth Ward. The project provides protection against the maximum flood of record, which occurred in 1886 and corresponds to a stage of 40.3 on the gauge on Fifth Avenue Bridge over the Oostanaula River.
