# Claiborne and Millers Ferry Locks and Dams Fish Passage Study

Appendix G: Geotechnical Engineering

May 2023

## APPENDIX-G: Geotechnical Engineering

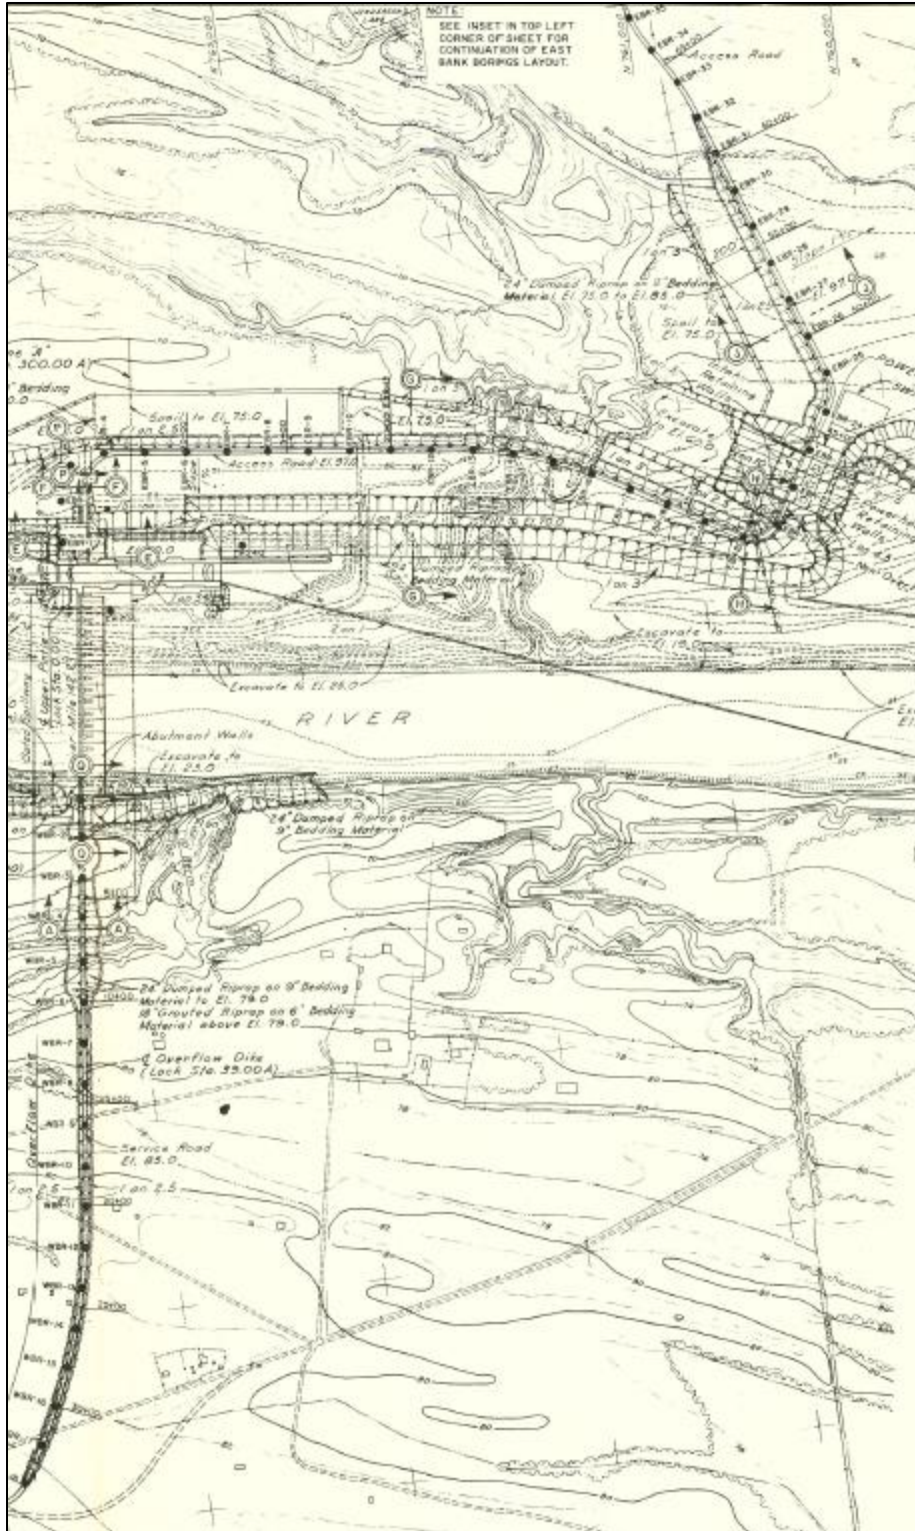
**Figure G-1: Geotechnical investigation boring approximate locations for the left and right embankments used for the feasibility level geotechnical analysis**

For the feasibility study, the USACE Mobile team is using the borings from Design Memorandums for Millers Ferry. Field exploration at the site consisted of obtaining undisturbed and split spoon machine boring samples along the axis of the right bank dike, left bank dike, and during construction core borings were made in the downstream area, three in right abutment wall, and four in the powerhouse area. Four-inch and six-inch cores were taken in proposed locations with 90% to 92% recovery. The borings advance to depths ranging between 10 to 135 feet below existing grade (BEG). The approximate locations are shown on Figure G-1 and Figure G-2, respectively.

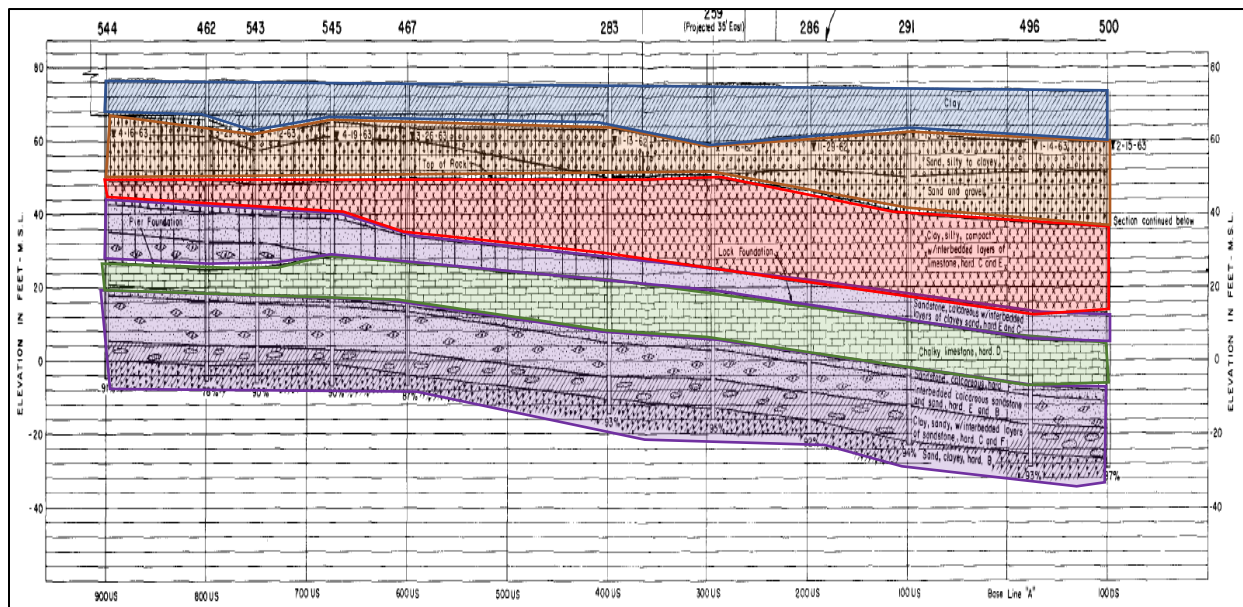
Figure G-5: Fence diagram North to South (Left to right) of the central bank with section taken parallel with flow of the river. (E-E)

The plan view of Millers Ferry geologic cross sections are shown in Figure G-3. Fence diagrams of the cross sections are provided in Figure G-4 Figure G-6. The legend for material type within the cross-sections is;

The subsurface stratigraphy can be described as four major strata: silts and clays, fine sands, clays, and limestone bedrock. The fine sands are mainly on the left portion of the dam from the central bank to the east bank. The west bank is primarily clay, fine sand, and bedrock. The upper clay layers on the west bank (right bank) generally are inorganic silts varying in depth from 29 feet at the bank river to 3 to 8 feet with average depth of 3 feet from stations 0+00 to 28+00 and turns to fat clays from 28+00 to 34+00. The east bank (left bank) is composed on mainly lean clay. The consistency of the upper and lower silt and clay layer is stiff. The consistency for the fine sand is stiff to hard.

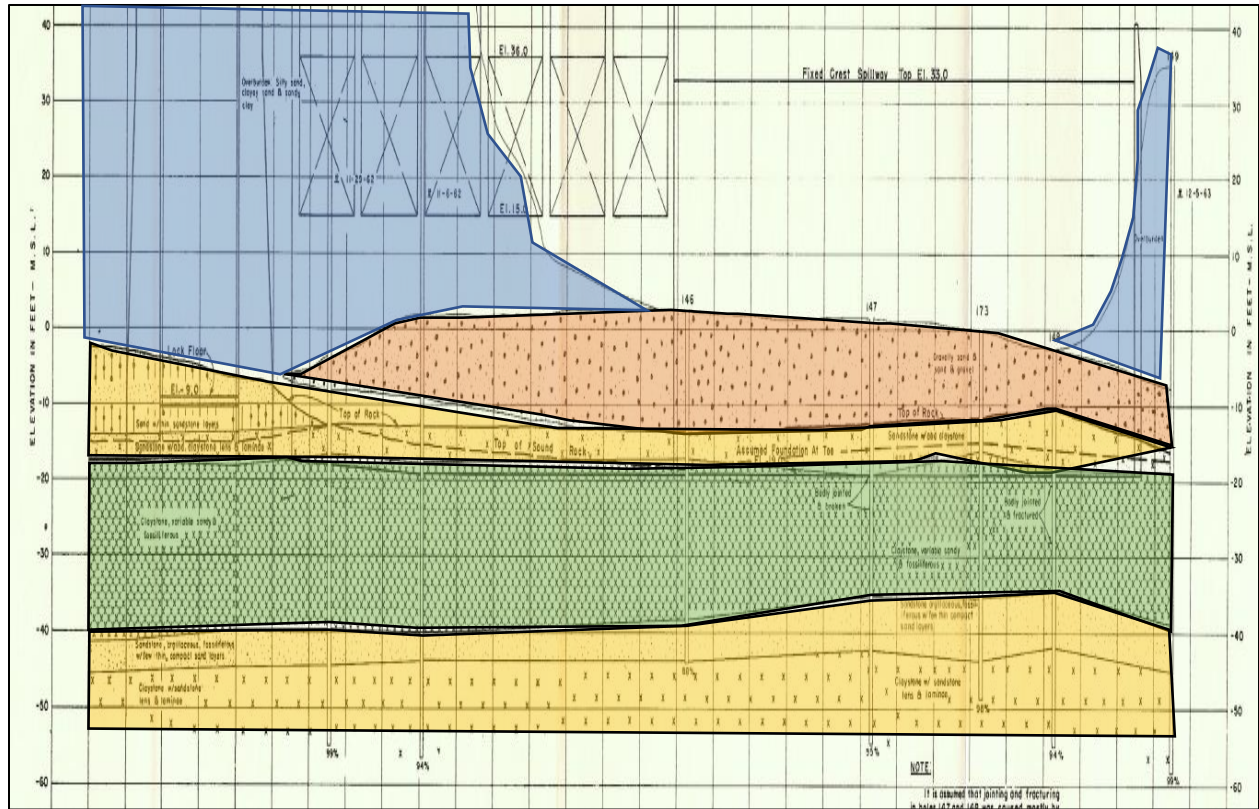
Figure G-8: Fence Diagram looking downstream, Lock on left and fixed crest spillway on the right.

Fence diagrams for the lithology at Claiborne is provided in Figure G-8. The overburden soil were discontinuous and alluvial deposits did not connect between borings. The legend for the type of material is;

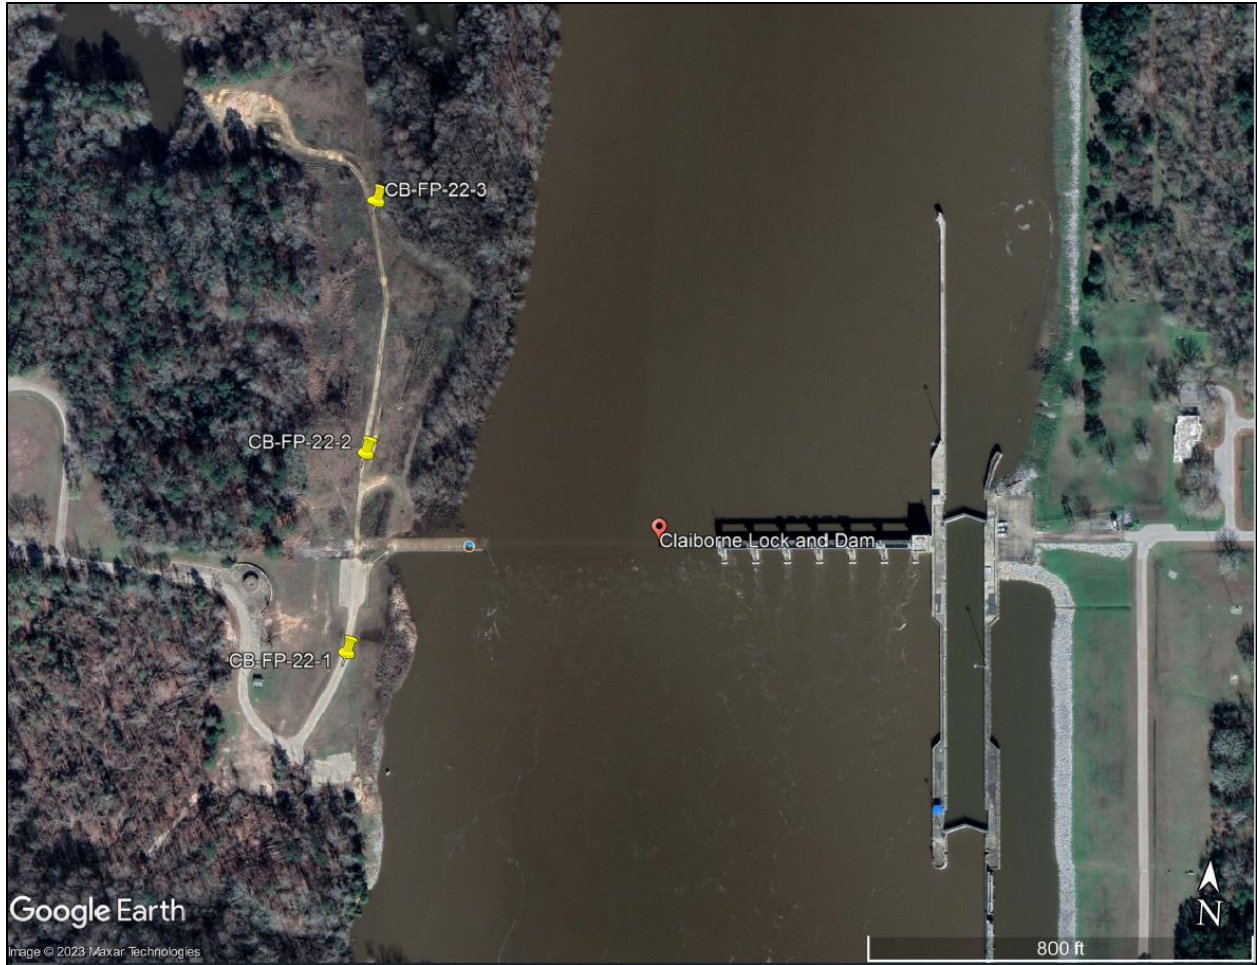
**Figure G-10: Proposed geotechnical investigation boring locations requested for Claiborne during this feasibility level study**

To support the feasibility level design for the fish passage channel three borings are proposed shown in Figure G-10.
