THE MEMPHIS DEPOT TENNESSEE

Defense Distribution Depot Memphis, Tennessee

FINAL

BRAC Parcel Summary Reports

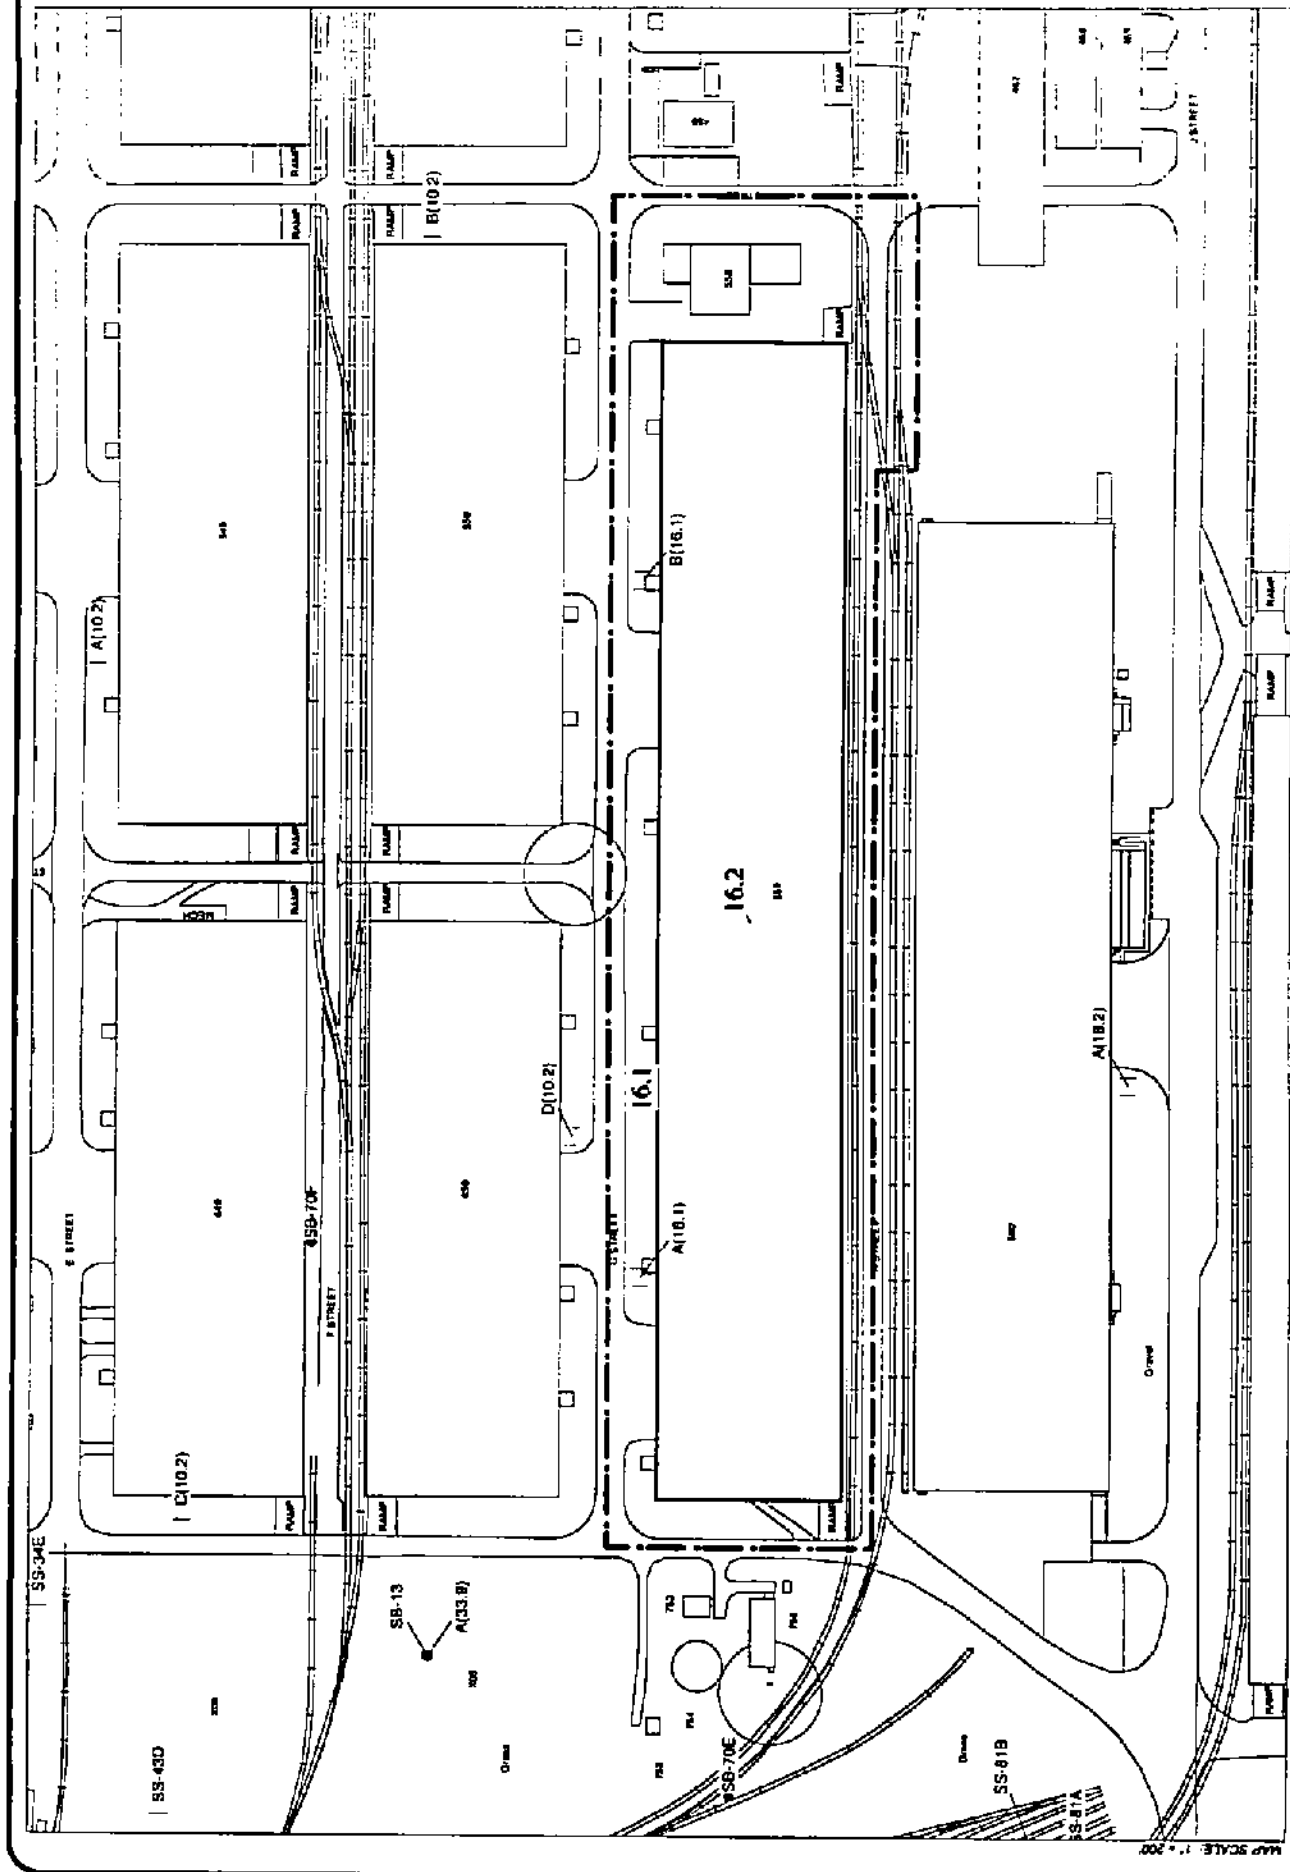
Figure 1
PARCEL 16
Sampling Locations

LEGEND

- Surface Soil Sampling Locations
- Soil Boring Sampling Locations
- Surface Water Sampling Locations
- Sediment Sampling Locations
- Parcel Boundary
- Sub-Parcel Boundary

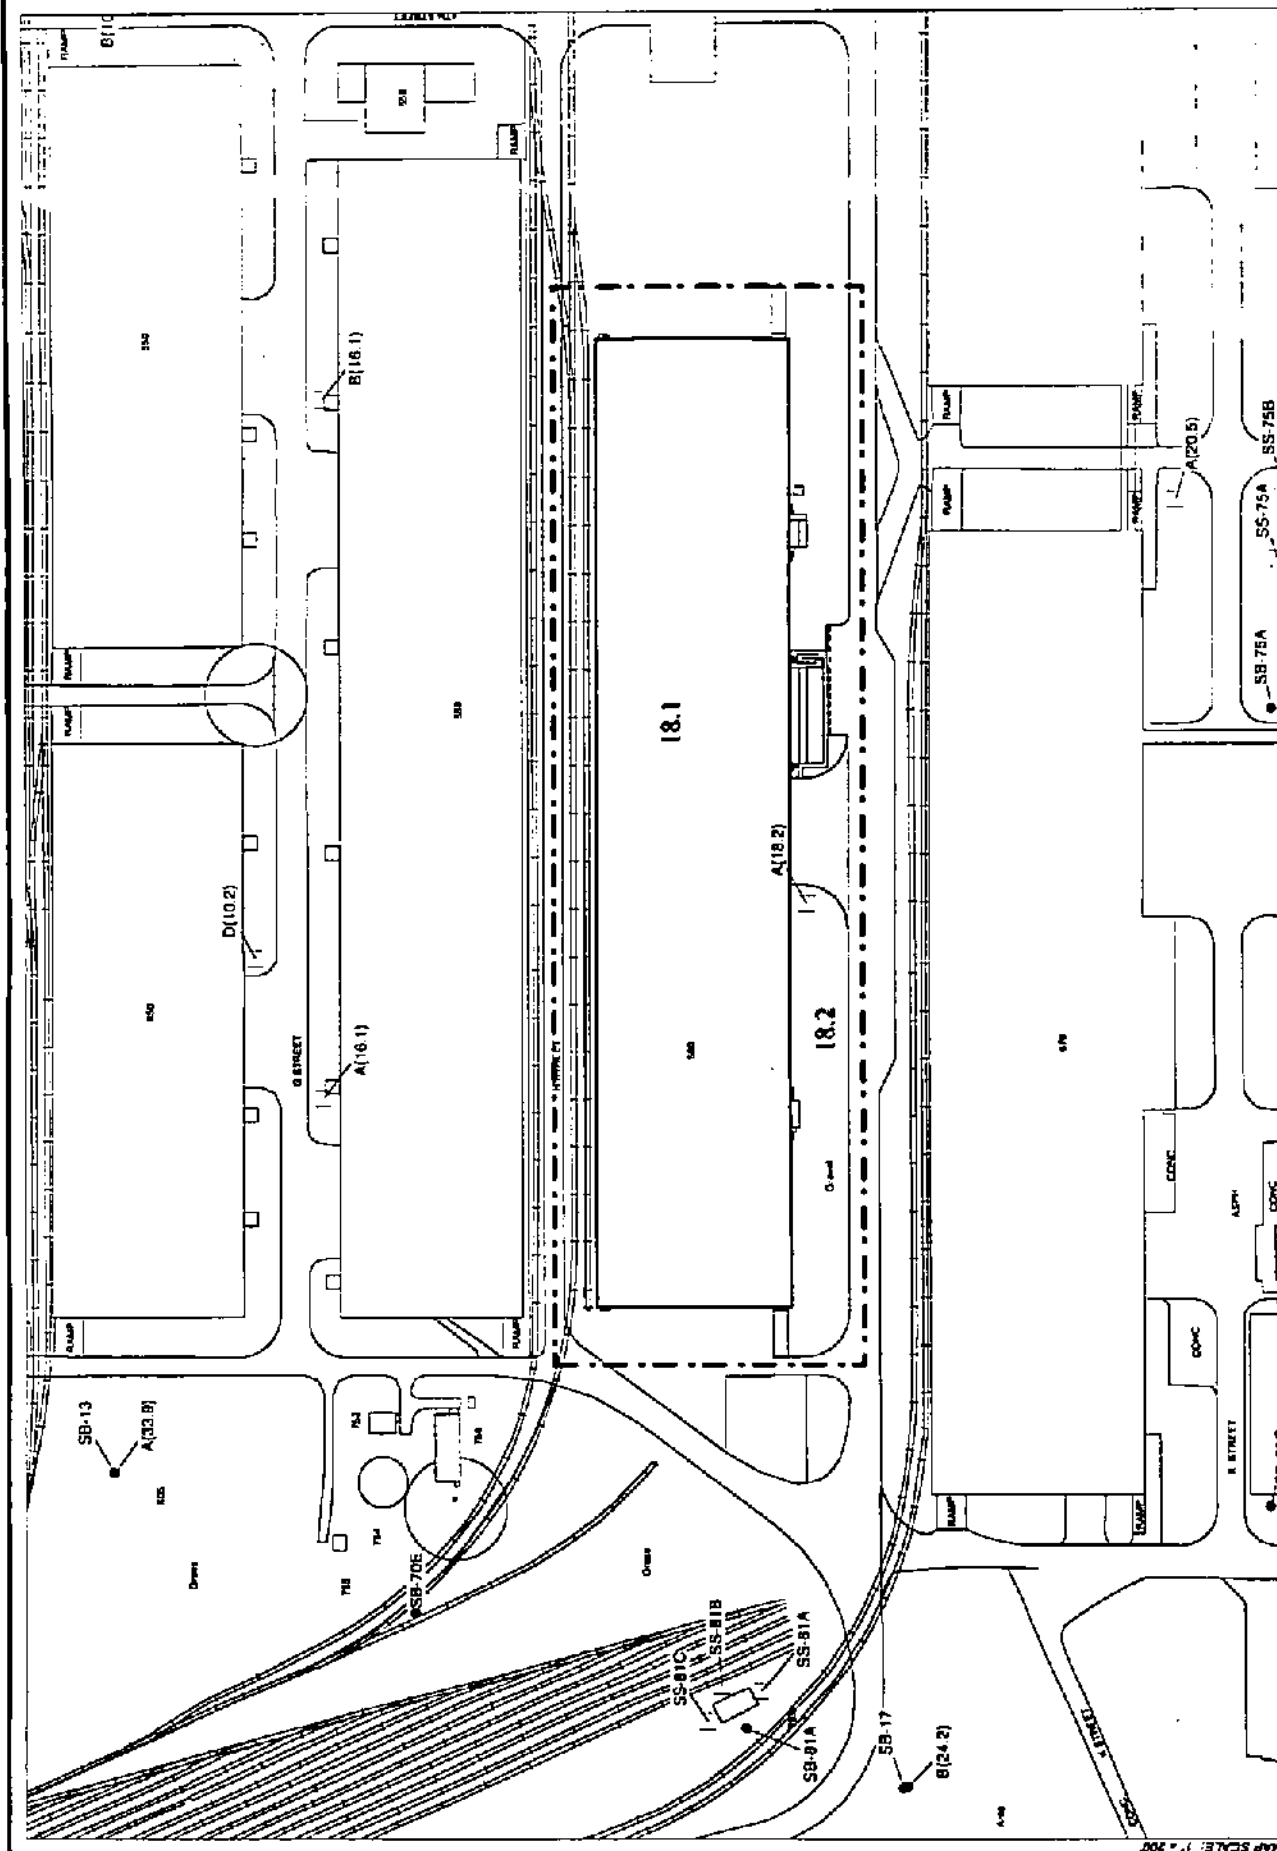
Figure 1
PARCEL 18
Sampling Locations

LEGEND

- Surface Soil Sampling Locations
- Soil Boring Sampling Locations
- Surface Water Sampling Locations
- Sediment Sampling Locations
- Parcel Boundary
- Sub-Parcel Boundary

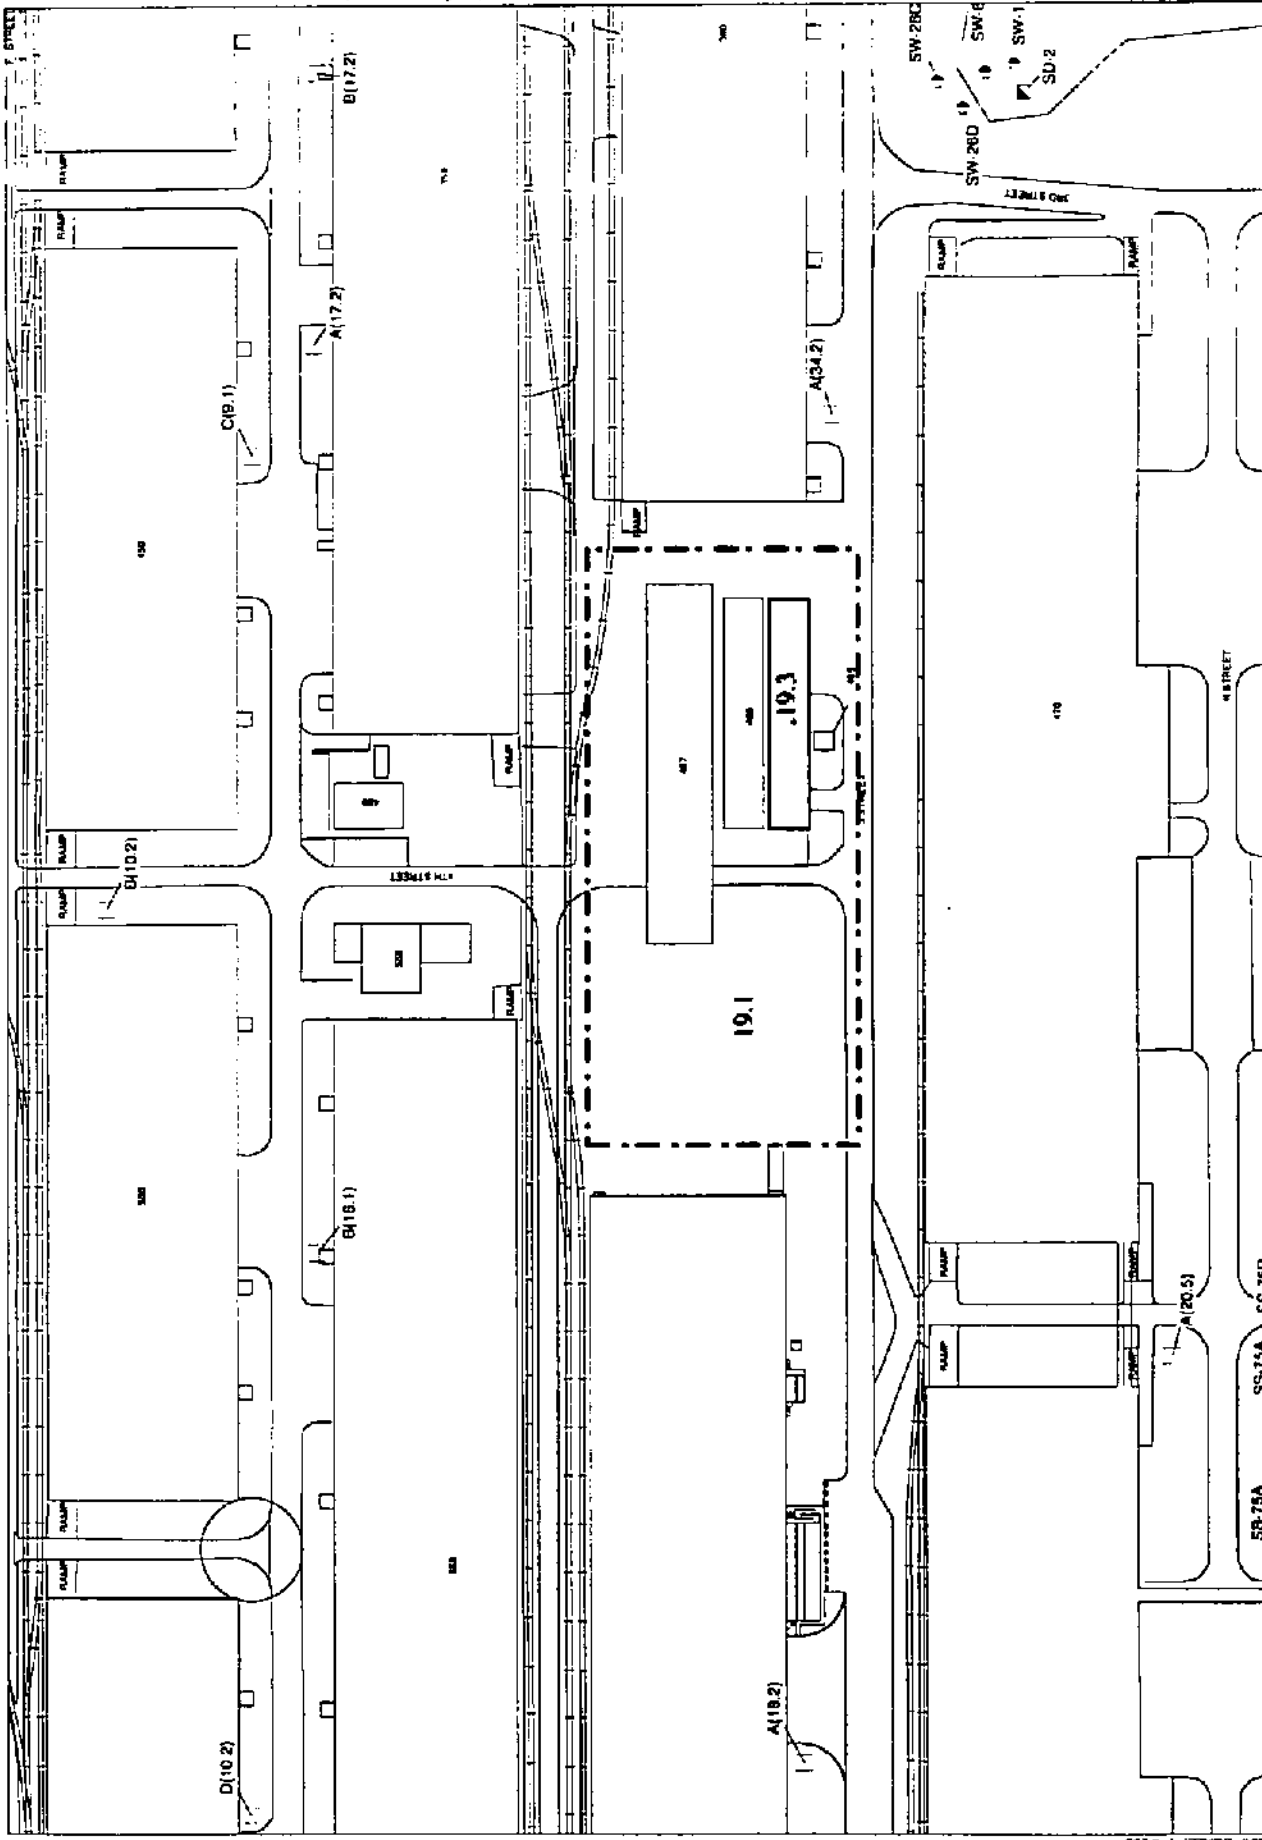
Figure 1
PARCEL 19
Sampling Locations

MAP SCALE: 1" = 200'

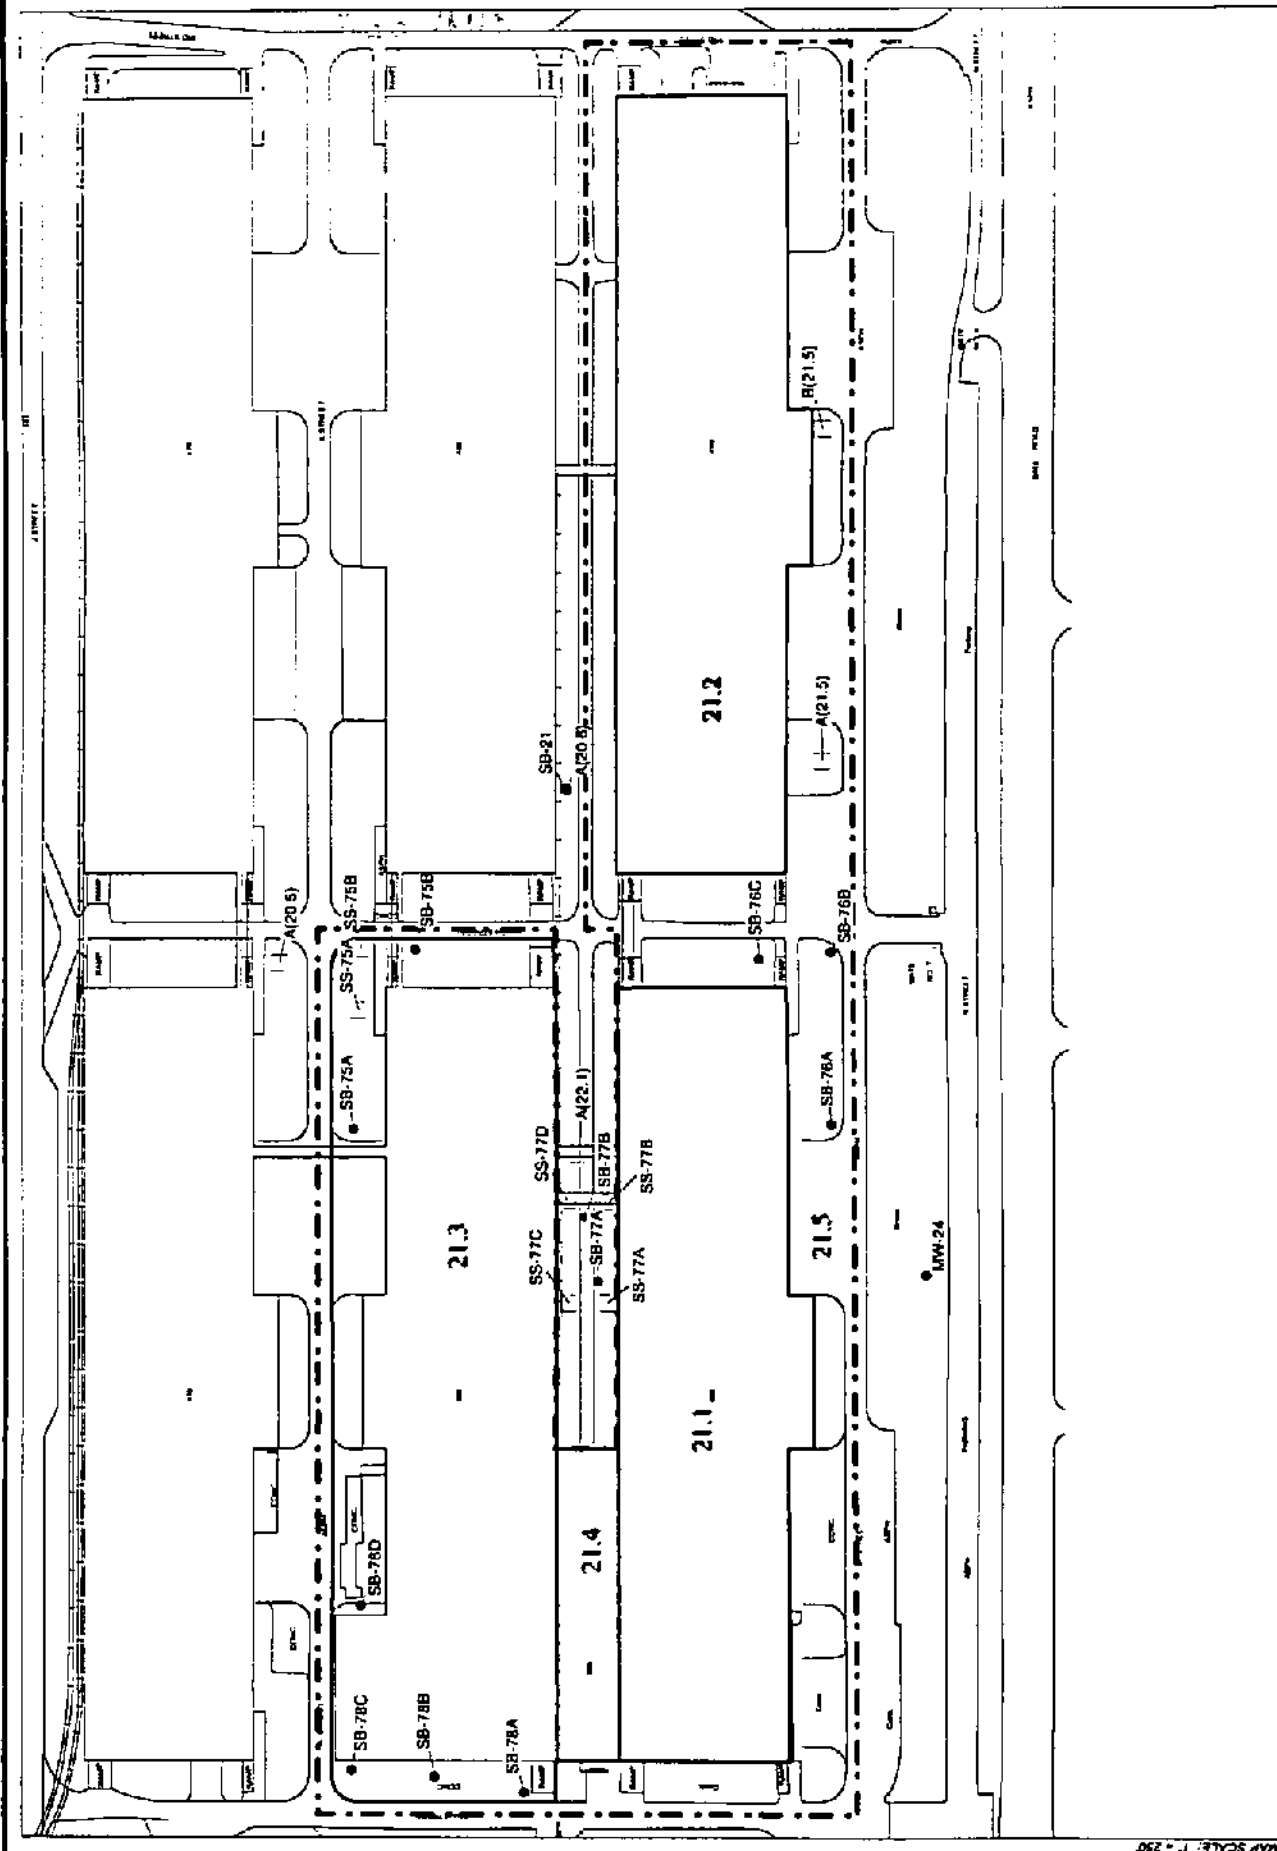
Figure 1
PARCEL 21
Sampling Locations
Defense Distribution Depot Memphis, TN

LEGEND

- Surface Soil Sampling Locations
- Soil Boring Sampling Locations
- Surface Water Sampling Locations
- Sediment Sampling Locations
- Parcel Boundary
- Sub-Parcel Boundary

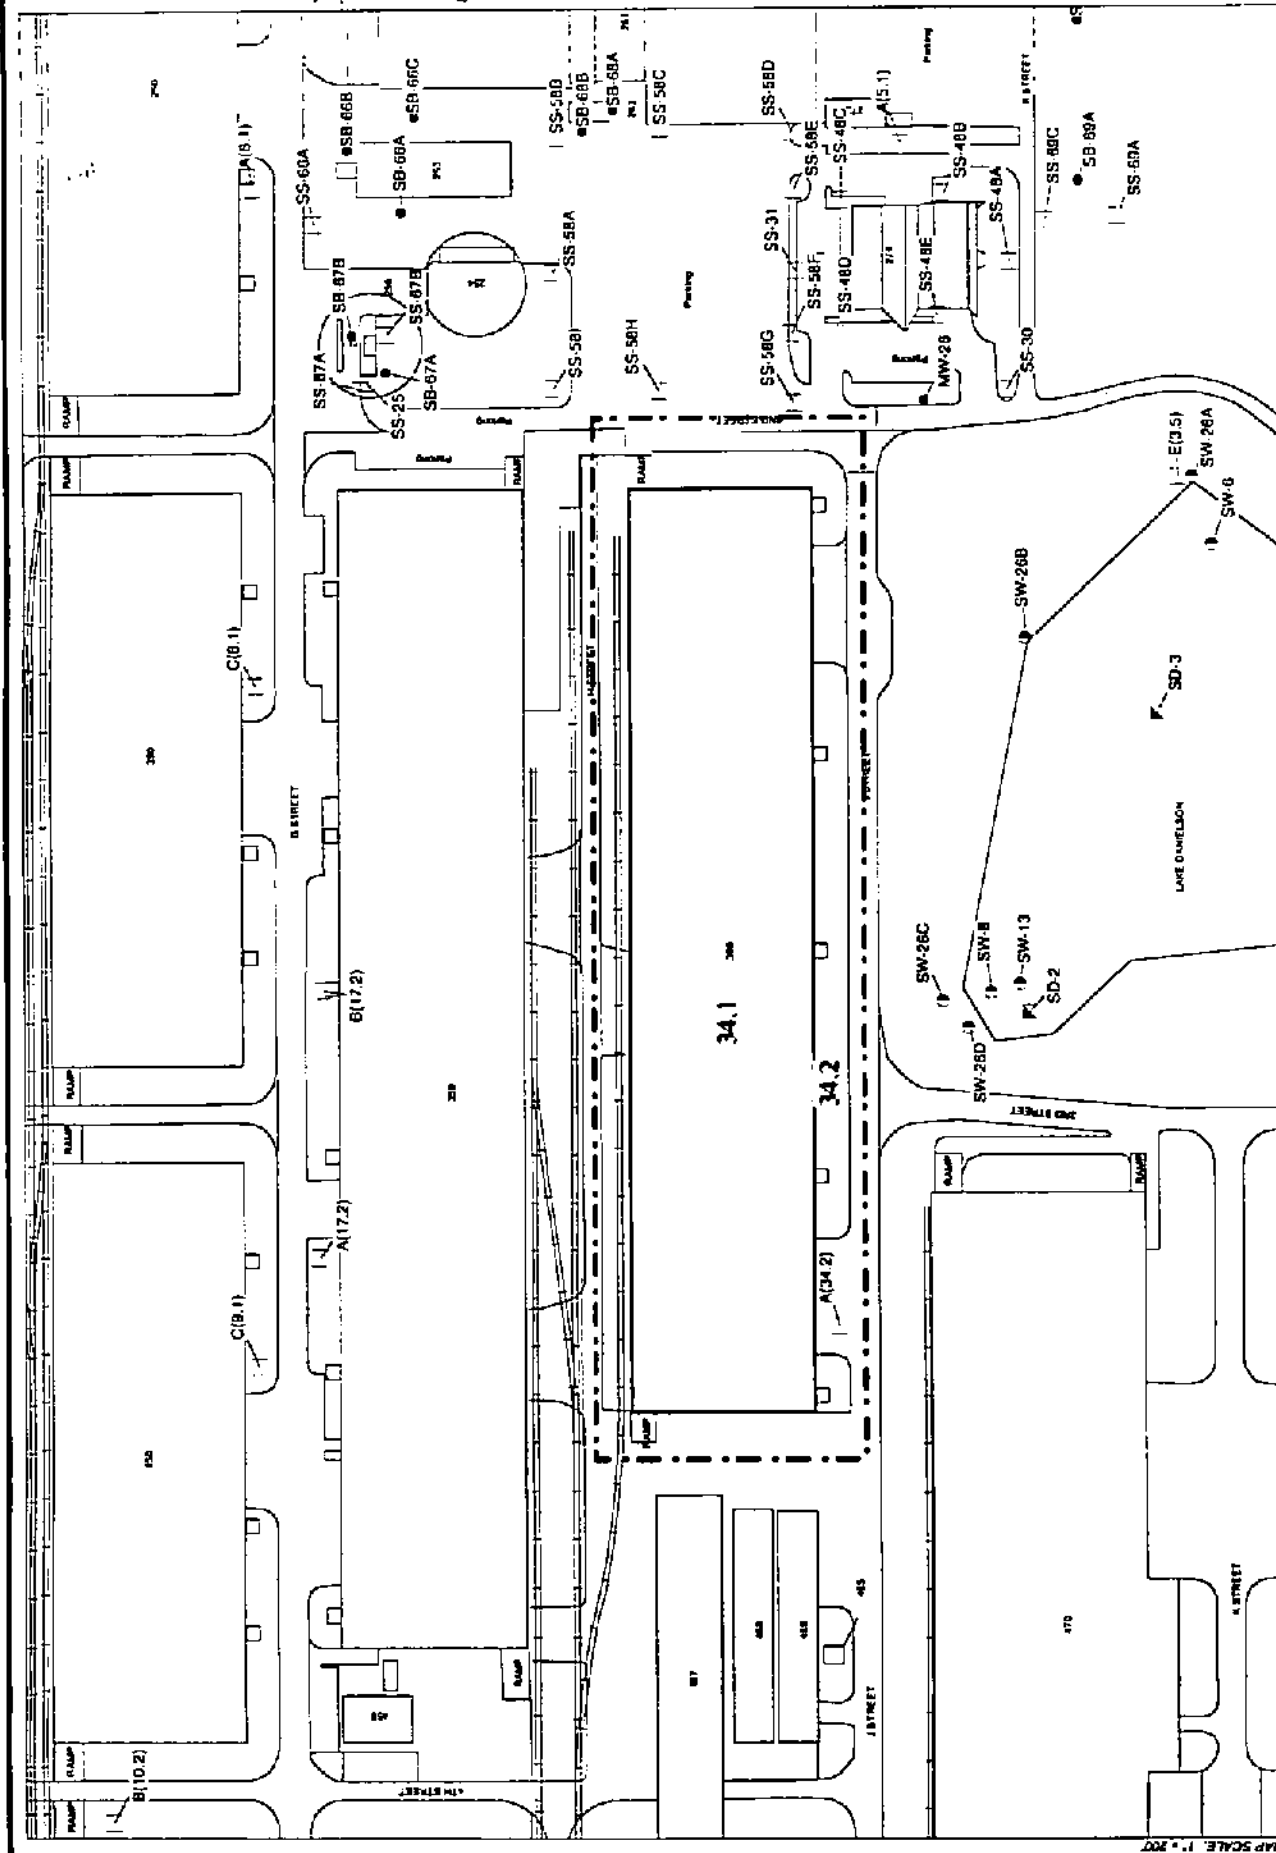
Figure 1
PARCEL 34
Sampling Locations

LEGEND

- Surface Soil Sampling Locations
- Soil Boring Sampling Locations
- Surface Water Sampling Locations
- Sediment Sampling Locations
- Parcel Boundary
- Sub-Parcel Boundary
