**US Army Corps  
of Engineers®**

# Claiborne and Millers Ferry Locks and Dams Fish Passage Study

## Appendix G – Geotechnical Engineering

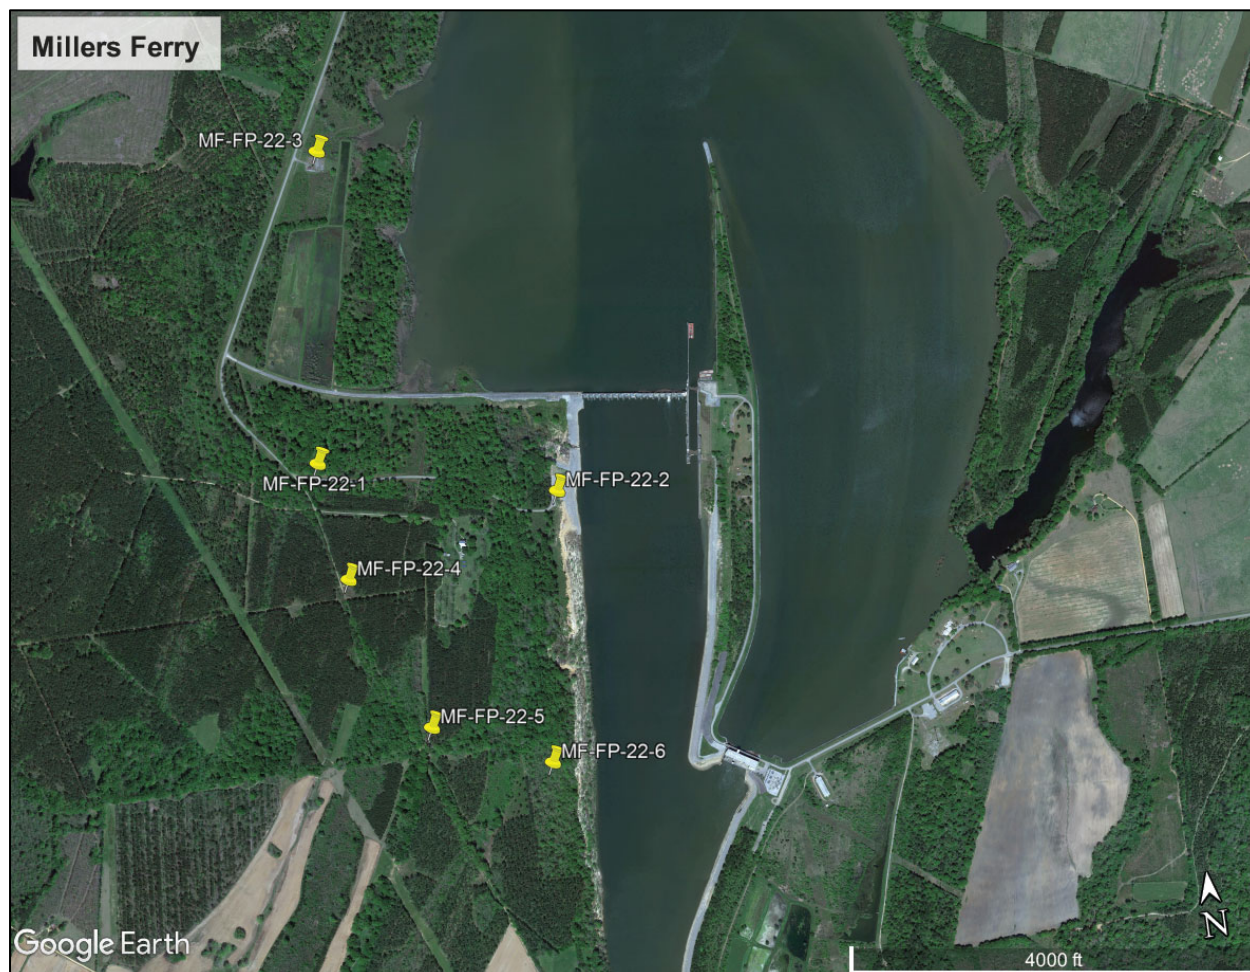
**Figure G-13: Proposed geotechnical investigation boring locations at Millers Ferry requested during this feasibility study**

To support the feasibility level design for the fish passage channel three borings are proposed shown in Figure G-13.

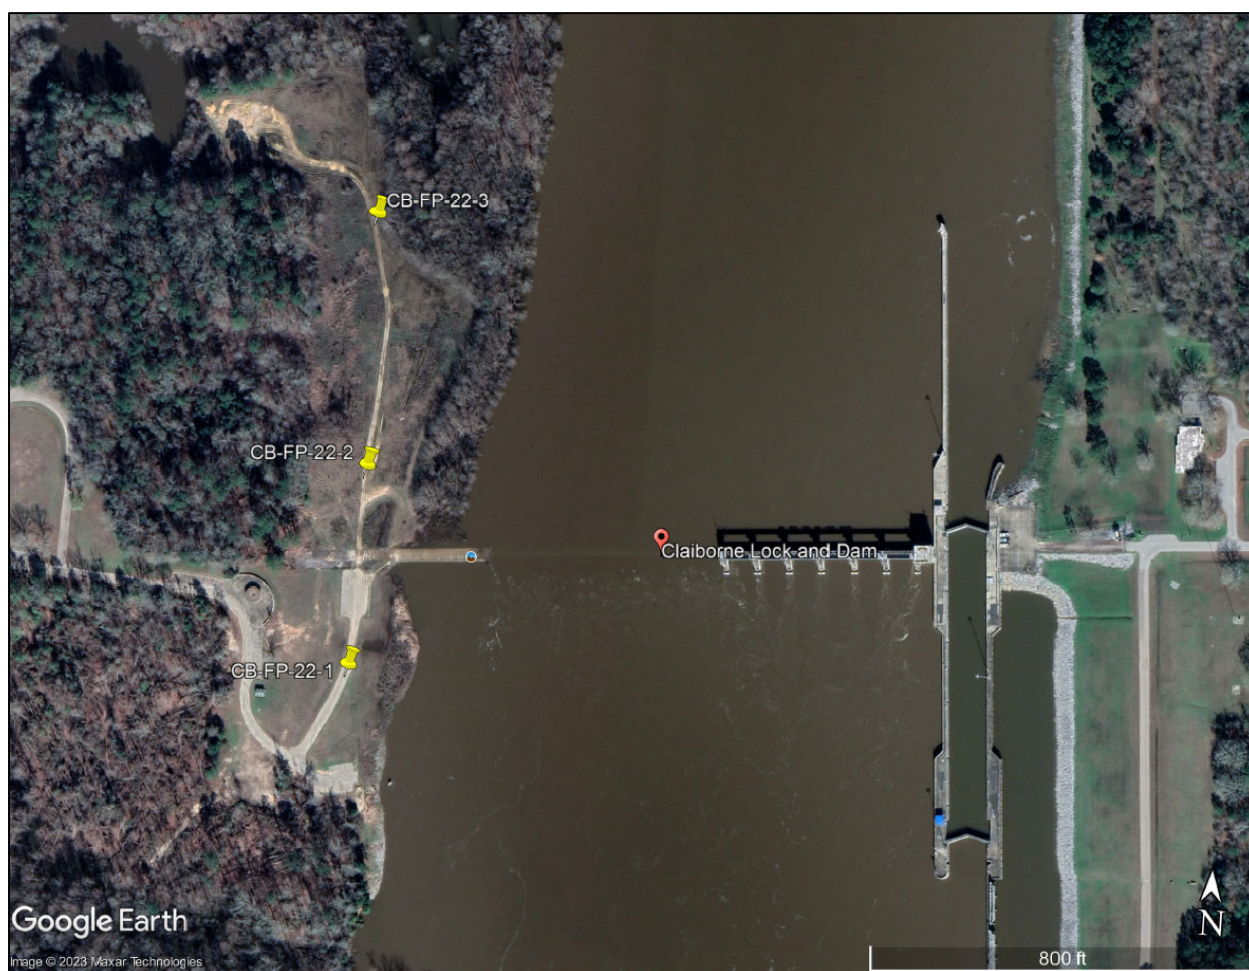
**Figure G-14: Proposed geotechnical investigation boring locations requested for Claiborne during this feasibility level study**

To support the feasibility level design for the fish passage channel three borings are proposed shown in Figure G-14.
