**FINAL  
DECISION DOCUMENT FOR THE  
GROUND SCAR SOUTH OF THE AUTOCRAFT SHOP, PARCEL 157(7)  
FORT McCLELLAN, CALHOUN COUNTY, ALABAMA**

**ISSUED BY: THE U. S. ARMY**

**JANUARY 2002  
REVISION 1**

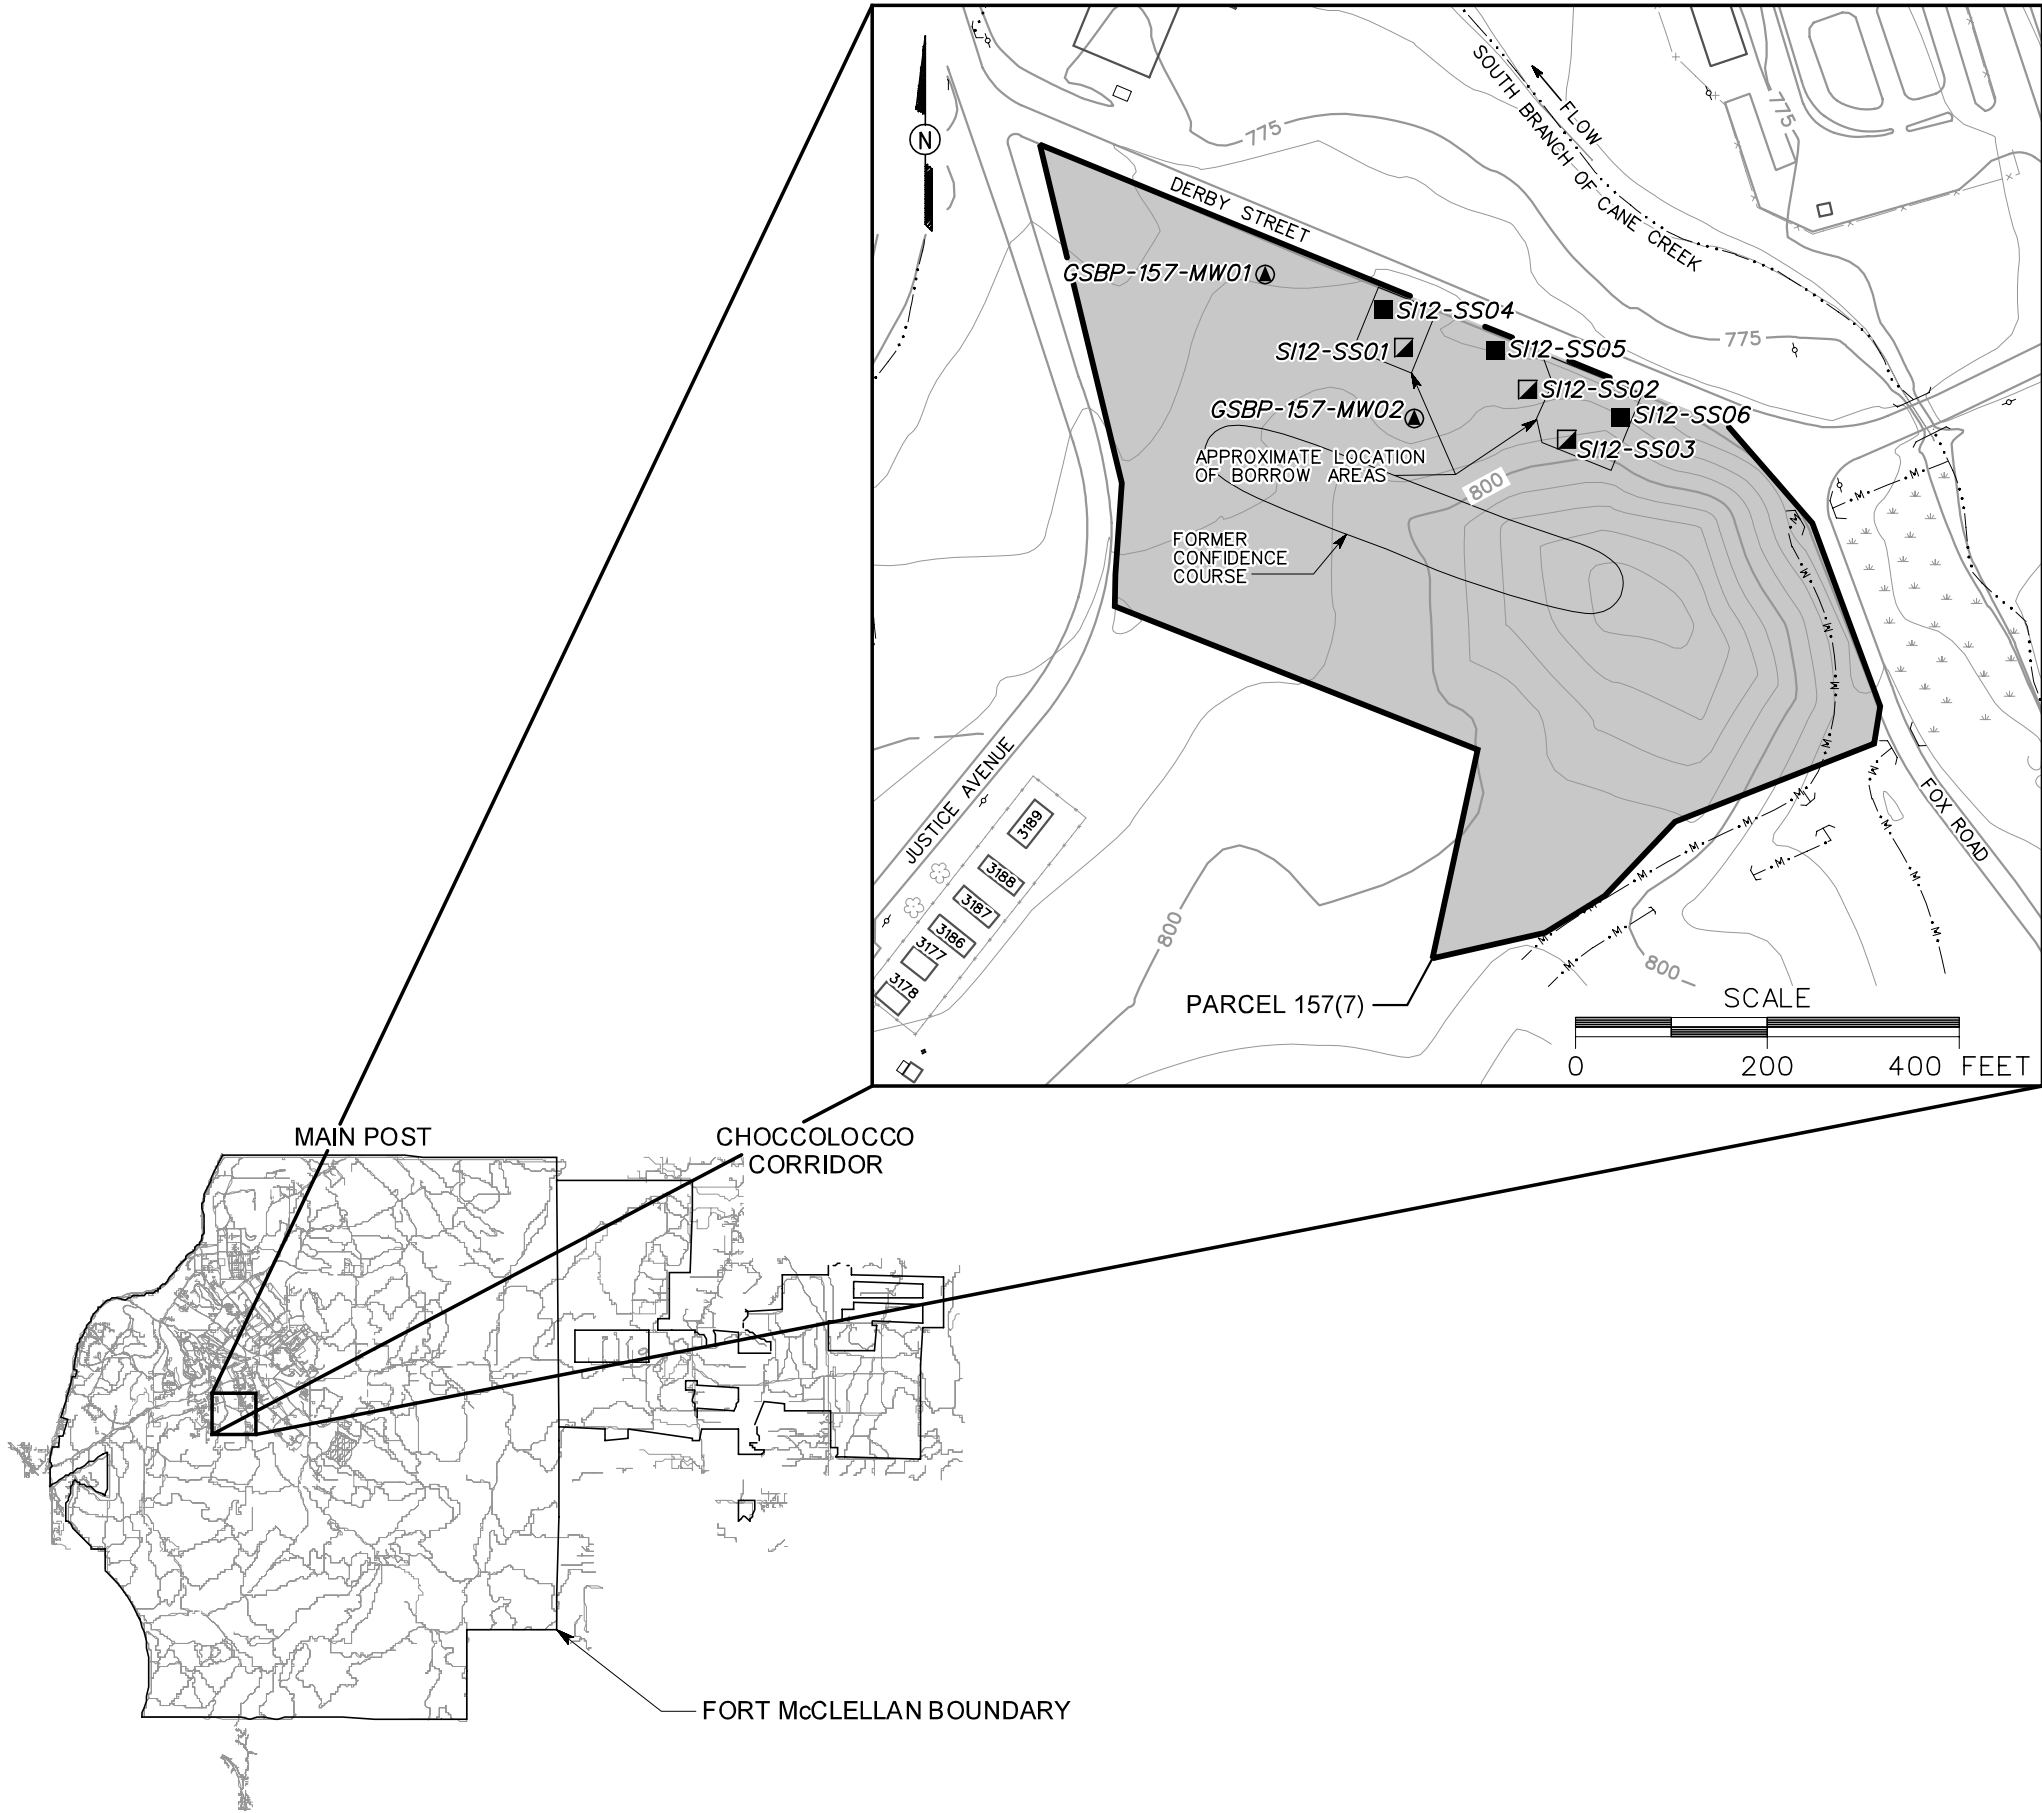
FIGURE 1  
SITE MAP  
GROUND SCAR SOUTH OF  
THE AUTOCRAFT SHOP  
PARCEL 157(7)

The Ground Scar South of the Autocraft Shop, Parcel 157(7), is located in the west-central portion of the FTMC Main Post (Figure 1), near the intersection of Derby Street (formerly 23rd Avenue) and Justice Avenue (formerly 11th Avenue). The area is bounded on the north by Derby Street and on the south by both

IT and QST collected a total of six surface soil samples, three

subsurface soil samples, and two groundwater samples. Groundwater samples were collected from two permanent monitoring wells installed during the site investigation. The samples were analyzed for metals, volatile organic compounds (VOC), semivolatile organic compounds (SVOC), pesticides, polychlorinated biphenyls (PCB), and nitroexplosive compounds. In addition, three soil samples were analyzed for total organic carbon content.

This Decision Document presents the determination that no further remedial action will be necessary to protect human health and the environment at the Ground Scar South of the Autocraft Shop, Parcel 157(7), at Fort McClellan (FTMC) in Calhoun County, Alabama. The location of the parcel at FTMC is shown on Figure 1. In addition, this Decision Document provides the site background information used as the basis for the no further action decision.
