CR 45 (Palos & Porter/Millers Steam Plant) Bridge (Mile 406.9)

Millers Steam Plant Spur Railroad Bridge (Mile 407.3)

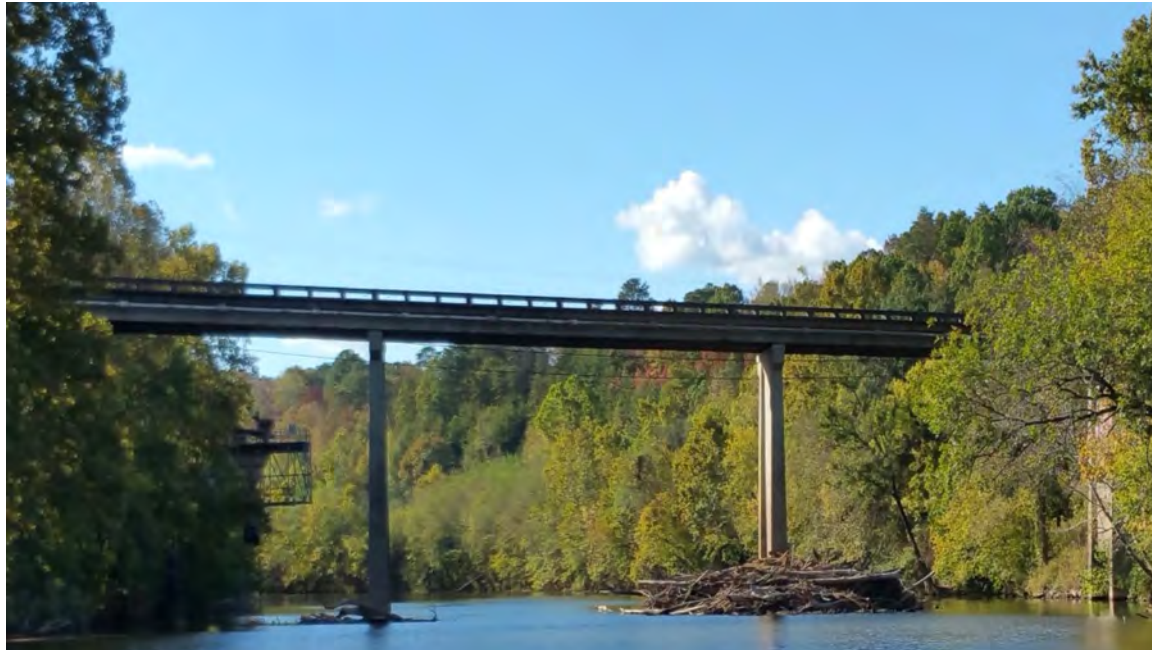
NOTE: POWER LINE CROSSING SHOWN IN PIC REP IS IMMEDIATELY DOWNSTREAM OF BRIDGE
 LOOKING DOWNSTREAM VIEW

CHANNEL SPAN						
VERTICAL DATUM	NGVD 29			NAVD 88		
	LEFT PIER	CENTER	RIGHT PIER	LEFT PIER	CENTER	RIGHT PIER
ELEVATION OF LOW STEEL	302.1	302.0	302.1	302.2	302.1	302.2
VERT. CLEARANCE AT PROJECT POOL STAGE	48.1	48.0	48.1	48.1	48.0	48.1
ELEVATION OF LOW WIRE	N/A	299.8	N/A	N/A	299.9	N/A
VERT. CLEARANCE AT PROJECT POOL STAGE	N/A	45.8	N/A	N/A	45.8	N/A

Horizontal Clearances were measured between piers above the water. The clearance below the water may be less than what is shown above. The water depth as shown is only a graphic representation for visual purposes. No field work has been performed to determine the depth of water.

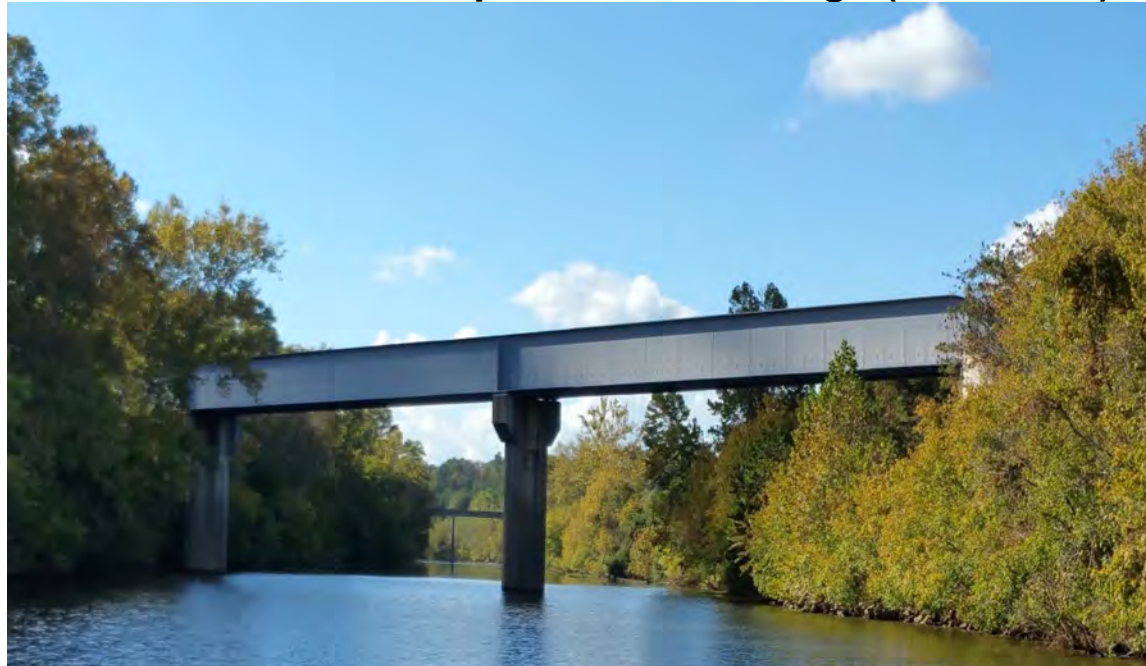
LOOKING DOWNSTREAM VIEW

CHANNEL SPAN						
VERTICAL DATUM	NGVD 29			NAVD 88		
	LEFT PIER	CENTER	RIGHT PIER	LEFT PIER	CENTER	RIGHT PIER
ELEVATION OF LOW STEEL	296.7	296.9	297.5	296.8	297.0	297.6
VERT. CLEARANCE AT PROJECT POOL STAGE	42.7	42.9	43.5	42.7	42.9	43.5

Horizontal Clearances were measured between piers above the water. The clearance below the water may be less than what is shown above. The water depth as shown is only a graphic representation for visual purposes. No field work has been performed to determine the depth of water.
