BLACK WARRIOR/TOMBIGBEE RIVER: DEMOPOLIS LOCK – UPPER MITER SILL FAILURE – 13 FEB 2024

BLACK WARRIOR/TOMBIGBEE RIVER: DEMOPOLIS LOCK – UPPER MITER SILL FAILURE – 20 JAN 2024

BLACK WARRIOR/TOMBIGBEE RIVER: DEMOPOLIS LOCK – UPPER MITER SILL FAILURE - 19 JAN 2024

BLACK WARRIOR/TOMBIGBEE RIVER: DEMOPOLIS LOCK – UPPER MITER SILL FAILURE - 16 JAN 2024

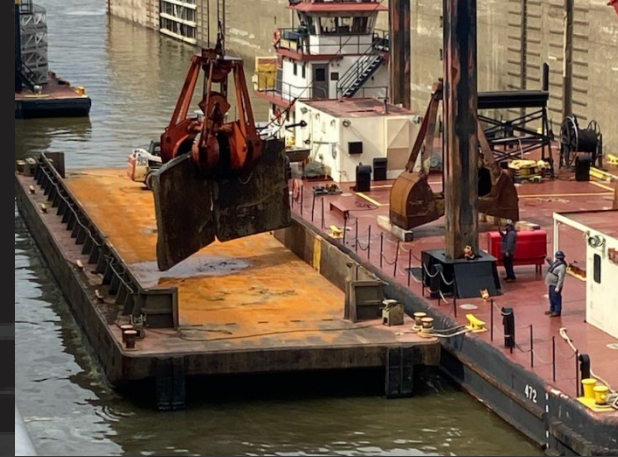
Floor Slab Debris Removal

The District Fleet began removing debris from the lock chamber. The success and completion of this effort depends on tailwater elevations and the fleet will continue the work when able.

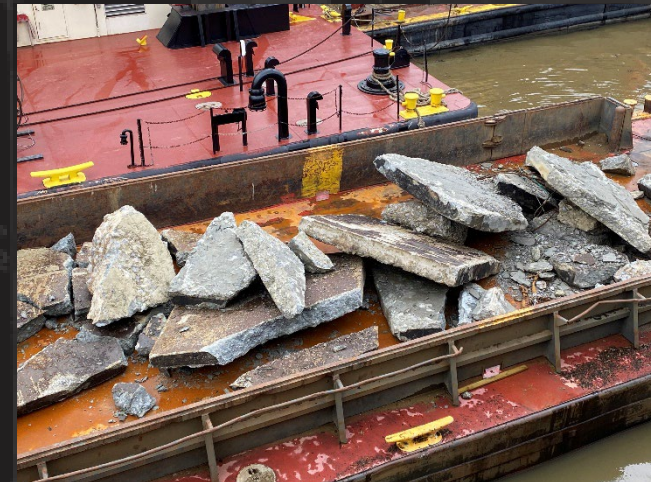
Concrete Debris Removal

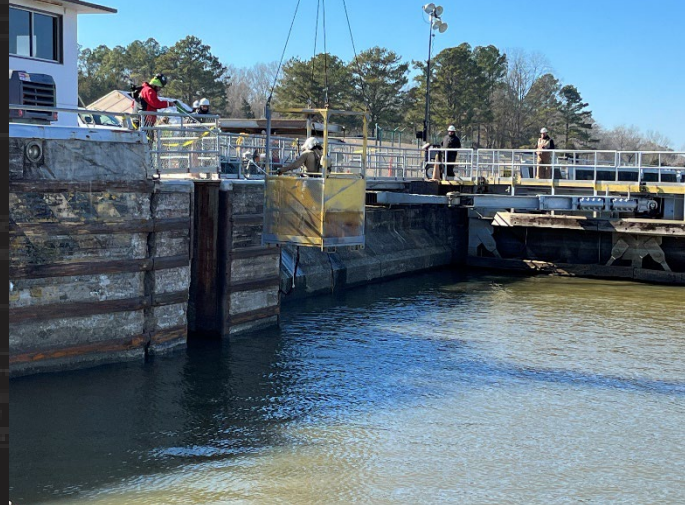
At 1300, the dive team inspected the stoplog slot. No issues were found.

Diver Inspecting Stoplog Slot

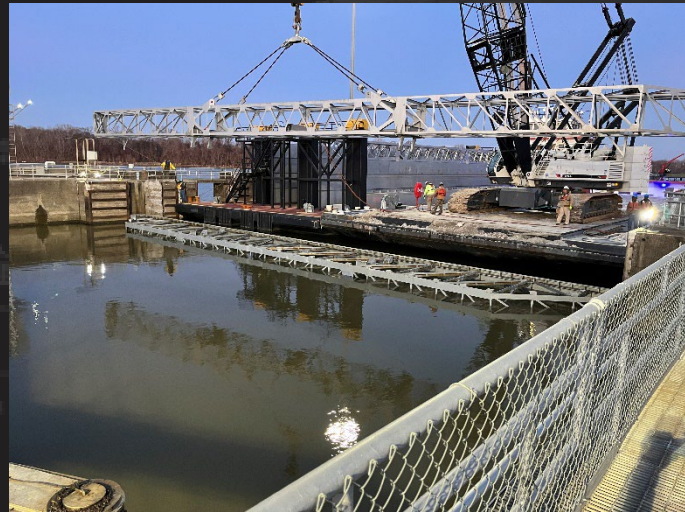
At 1330, TVA began setting 5 stoplogs (1 heavy, 2 regular BWT, 2 regular TTWW). Last stoplog was set at 1700.

Setting Stoplogs

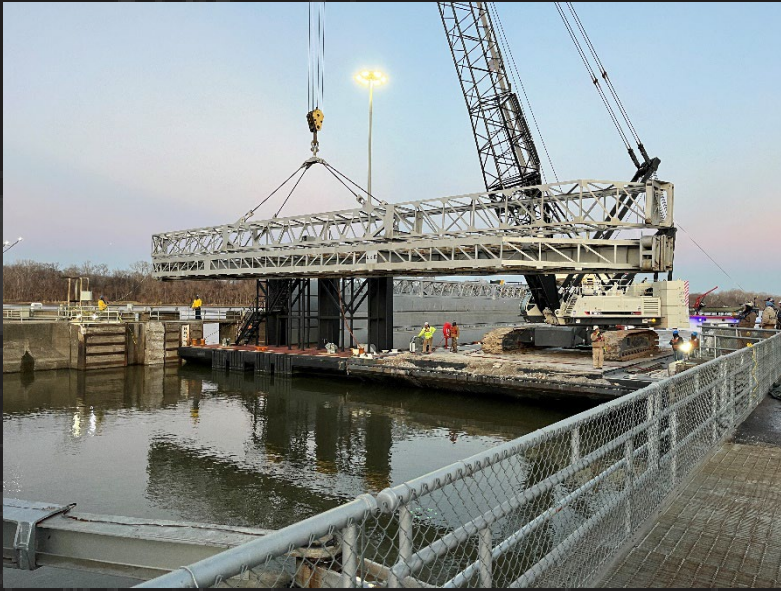
Last Stoplog Set
