BLACK WARRIOR/TOMBIGBEE RIVER: DEMOPOLIS LOCK – UPPER MITER SILL FAILURE – 6 FEB 2024

BLACK WARRIOR/TOMBIGBEE RIVER: DEMOPOLIS LOCK – UPPER MITER SILL FAILURE – 20 JAN 2024

BLACK WARRIOR/TOMBIGBEE RIVER: DEMOPOLIS LOCK – UPPER MITER SILL FAILURE - 19 JAN 2024

BLACK WARRIOR/TOMBIGBEE RIVER: DEMOPOLIS LOCK – UPPER MITER SILL FAILURE - 16 JAN 2024

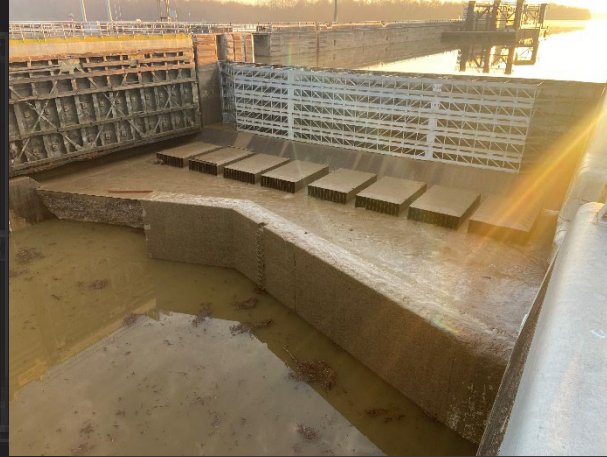
Damaged Sill

District Engineering has finalized the plans & specifications for the sill repair. The modification to the O&M contract should be awarded this week.

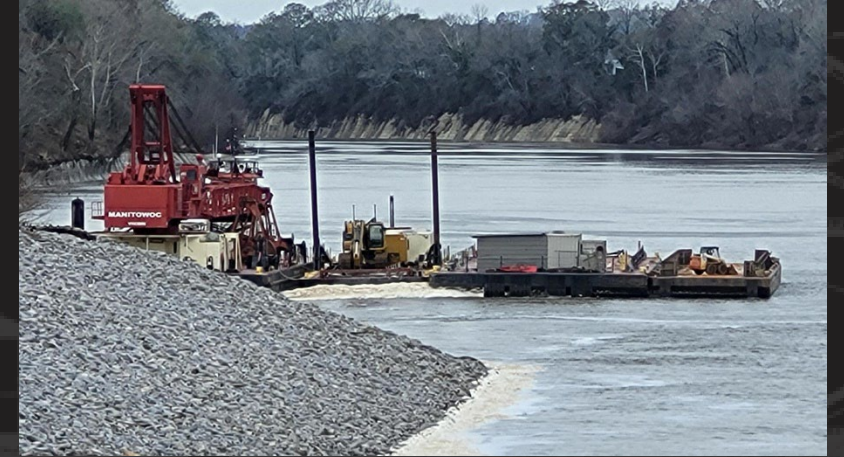
District Fleet Downstream
for Debris Removal

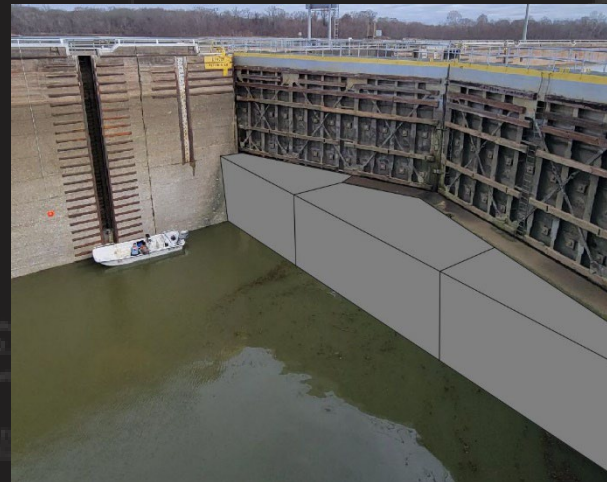
Rendering of Repair

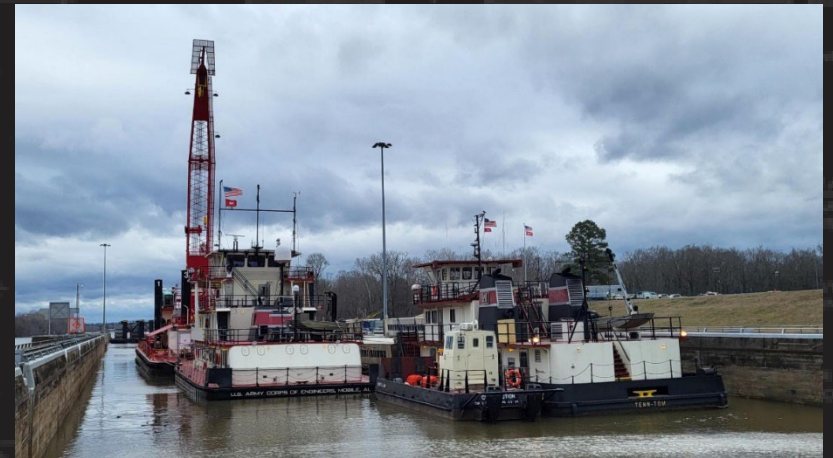
The District Fleet arrived at Demopolis Lock on Friday (2/2) evening. Saturday (2/3) morning, fleet components were positioned to assist with lifting the stoplogs and place support machinery and equipment for the upcoming work. The upper stoplogs were cracked open to fill the chamber and allow the fleet to reposition.

Fleet Positioning for
Upcoming Work

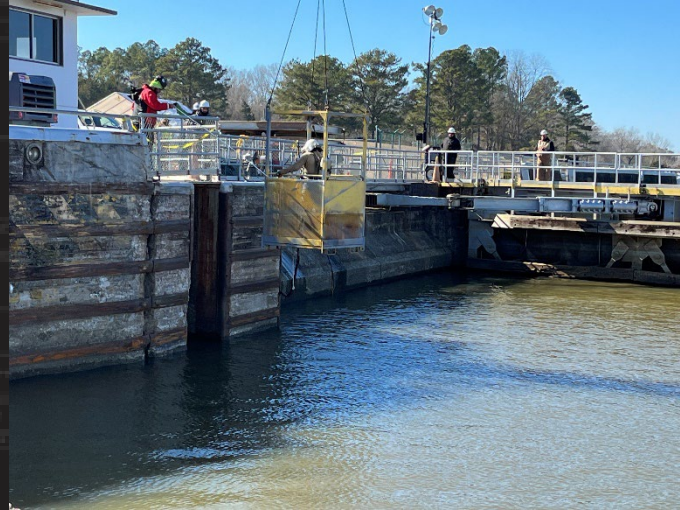
At 1300, the dive team inspected the stoplog slot. No issues were found.

Diver Inspecting Stoplog Slot

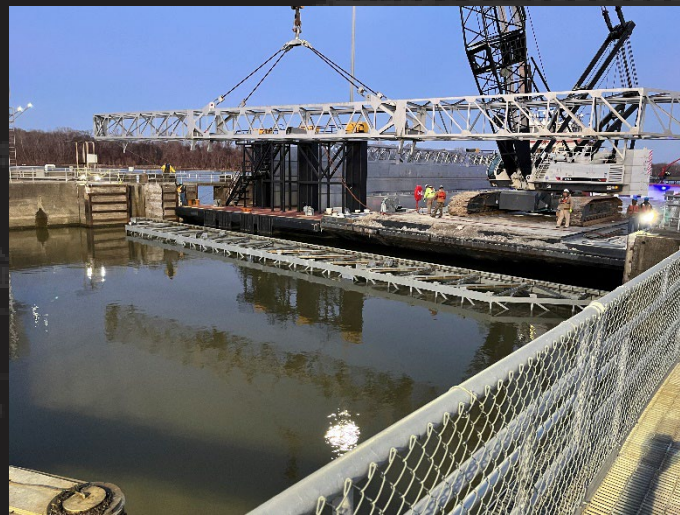
At 1330, TVA began setting 5 stoplogs (1 heavy, 2 regular BWT, 2 regular TTWW). Last stoplog was set at 1700.

Setting Stoplogs

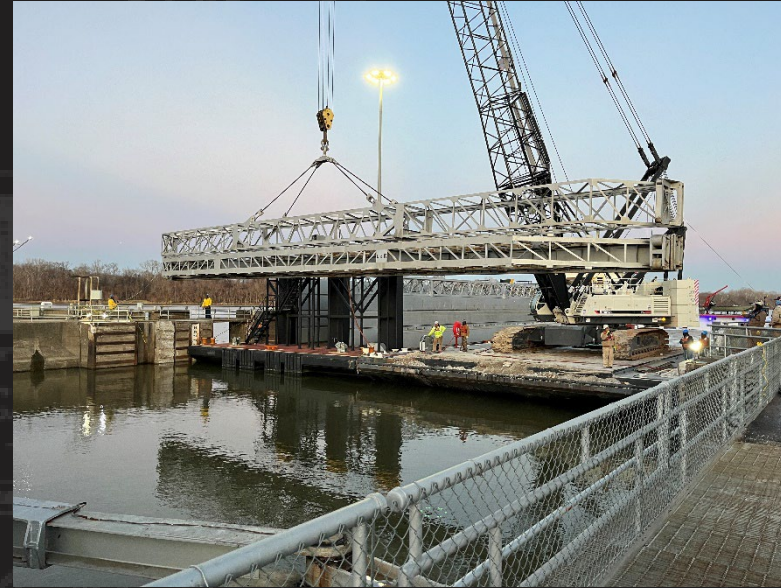
Last Stoplog Set

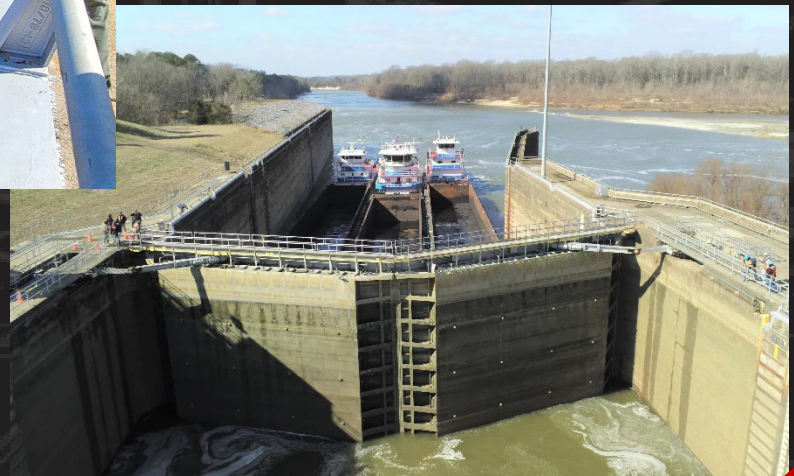
The lower miter gates were moved out of recess at 1130 and, following the gate closing procedure, were successfully placed into mitered position by 1145.

Lower Miter Gates Closing

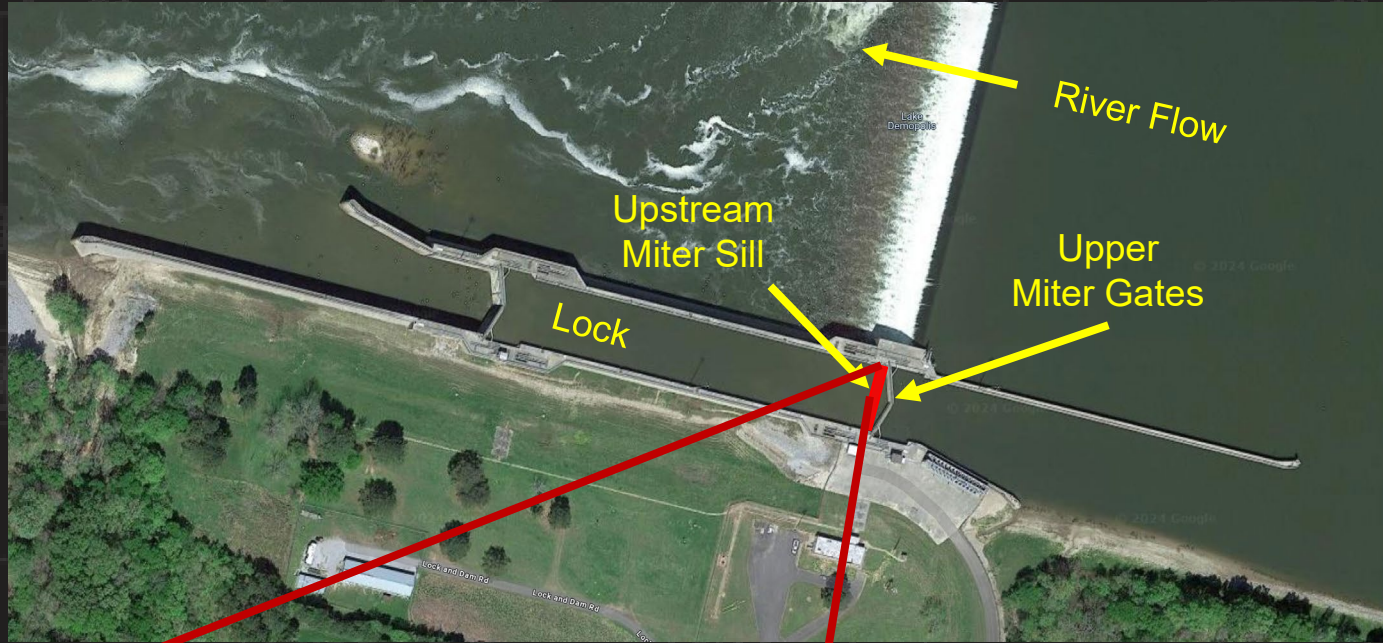
16 January 2024 Incident:
At 0600 the on-duty lock operator heard a loud noise and while investigating noticed water flowing under the upper miter gate. The concrete that comprises the upper miter sill fractured, allowing water to pass under the gate. The lower lock gates were open at time of the incident.

Current operations are to close the lower miter gates to allow the pool to equalize and set the upper stoplogs to get the lock chamber under control. Operation will take place 19-21 January. Engineering and Operations are continuing to analyze the extent of damages and are working other courses of action to stop the flow and get the lock under control.
